The Old Quadrangle

Retrofitting a significant heritage building to Passive House EnerPHit standard

University of Melbourne, Parkville VIC

October 2019

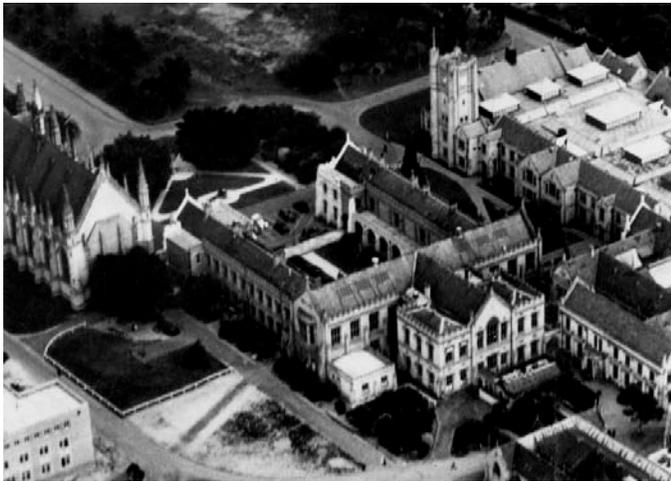
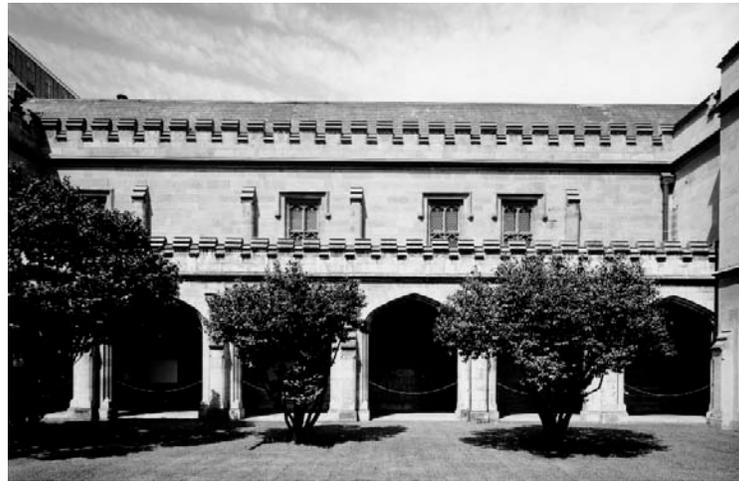
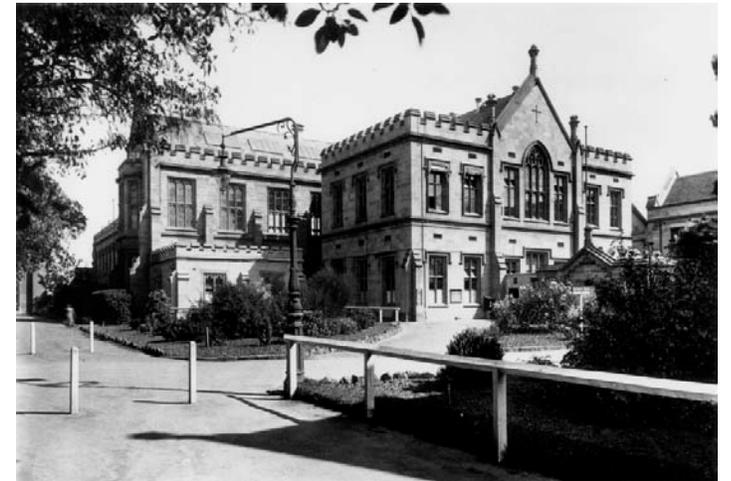
BUILDING EVOLUTION

- 1854-55
- 1856-57
- 1874-75
- 1930
- 1969-70 (Council Chambers) + 1981 (Cloister)

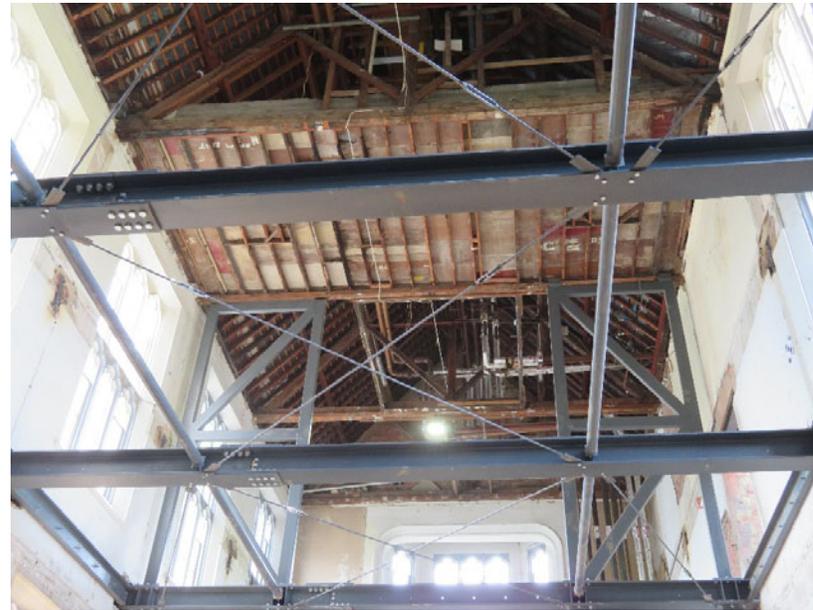
STRENGTHENING EXISTING BUILDINGS FOR EARTHQUAKE

Strengthening the Old Quad for earthquake protection was triggered due to the size and nature of the project. This was challenging to detail in the north wing as it required substantial steel structural members that needed to be concealed, thermally separated to minimise energy loss through the steel, and rigid structural connections throughout the airtightness envelope.

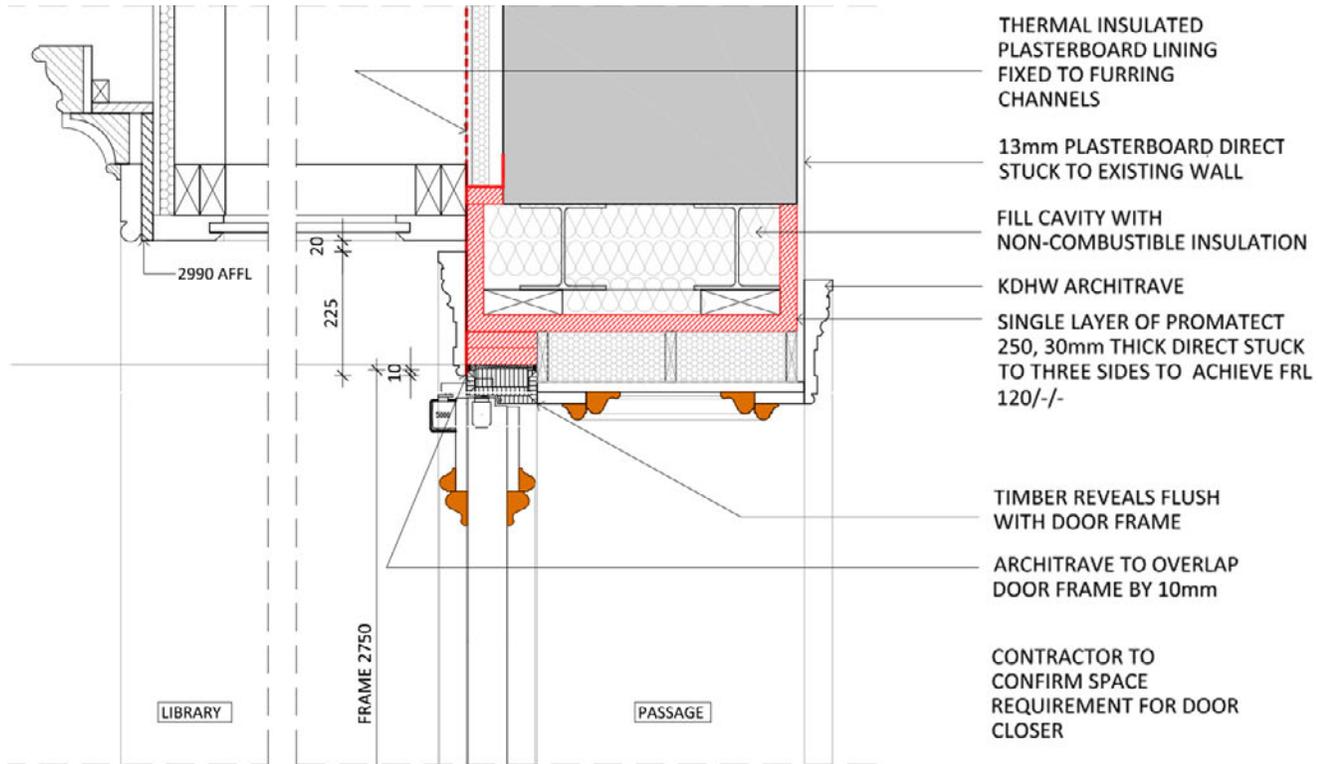
NND122 HEAD

The building is divided into several fire compartments which require separation where the wings abut each other. Careful detailing was necessary to achieve the fire separation and ensure thermal bridges have been eliminated in the critical fire rating details.

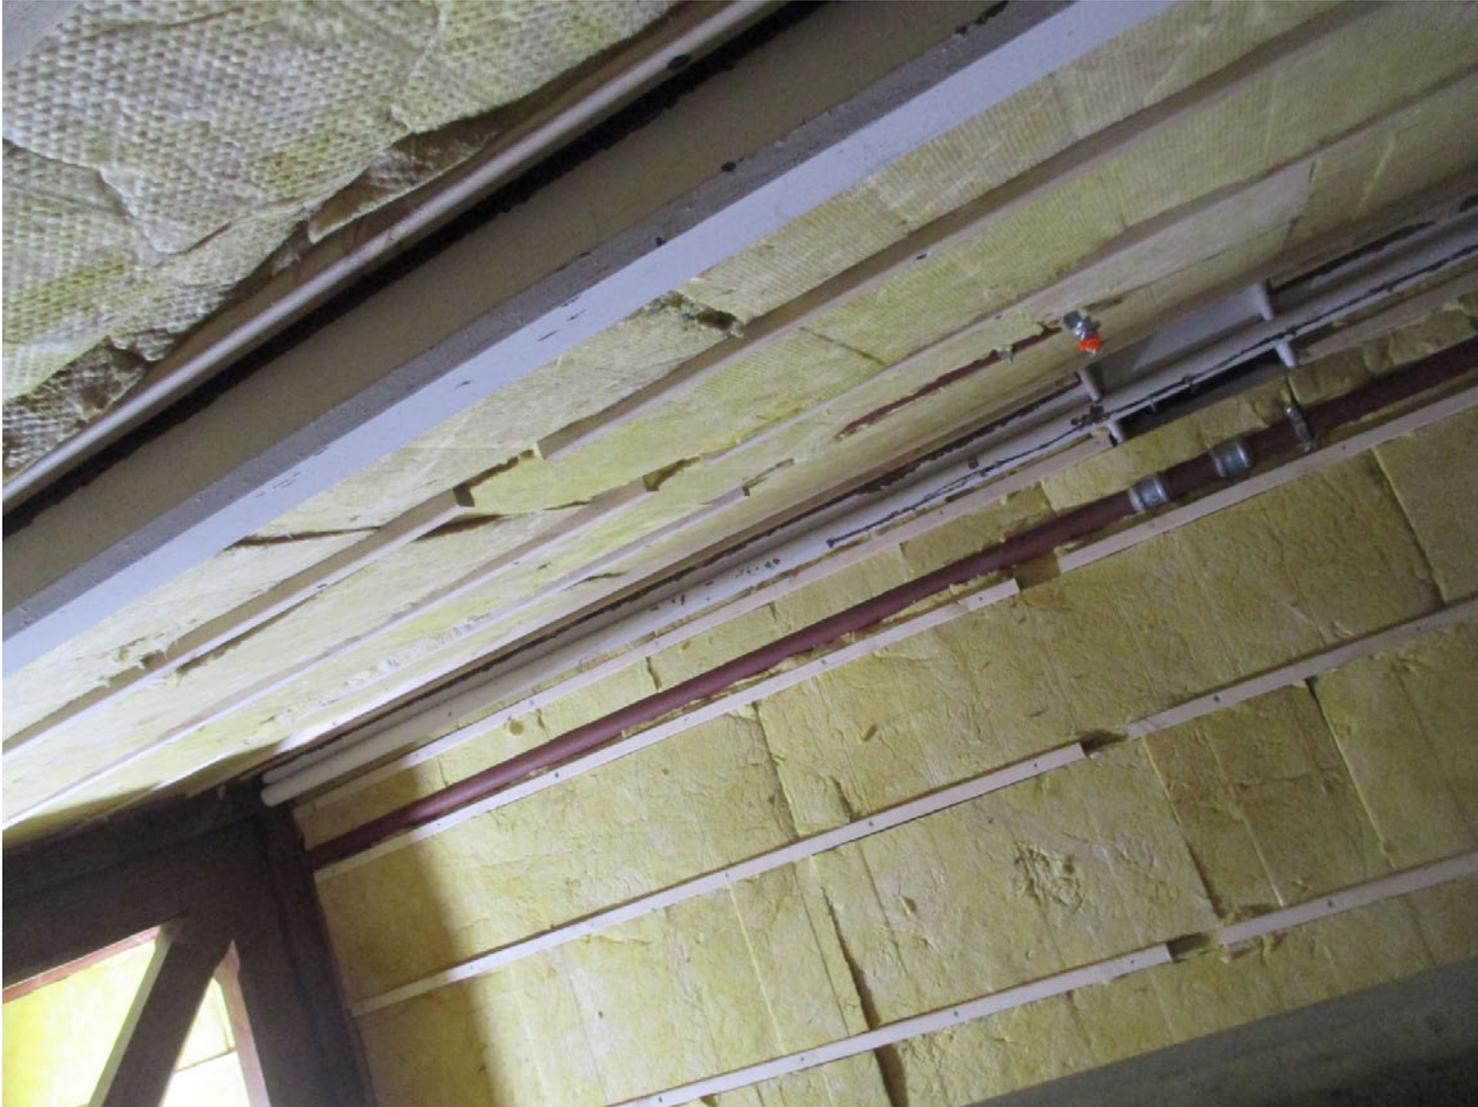
HYDRANT AND SPRINKLER PROTECTION

Sprinkler protection of the building was challenging due to the limited space for concealment which is usually shared by the necessary components required to achieve thermal insulation and airtightness.

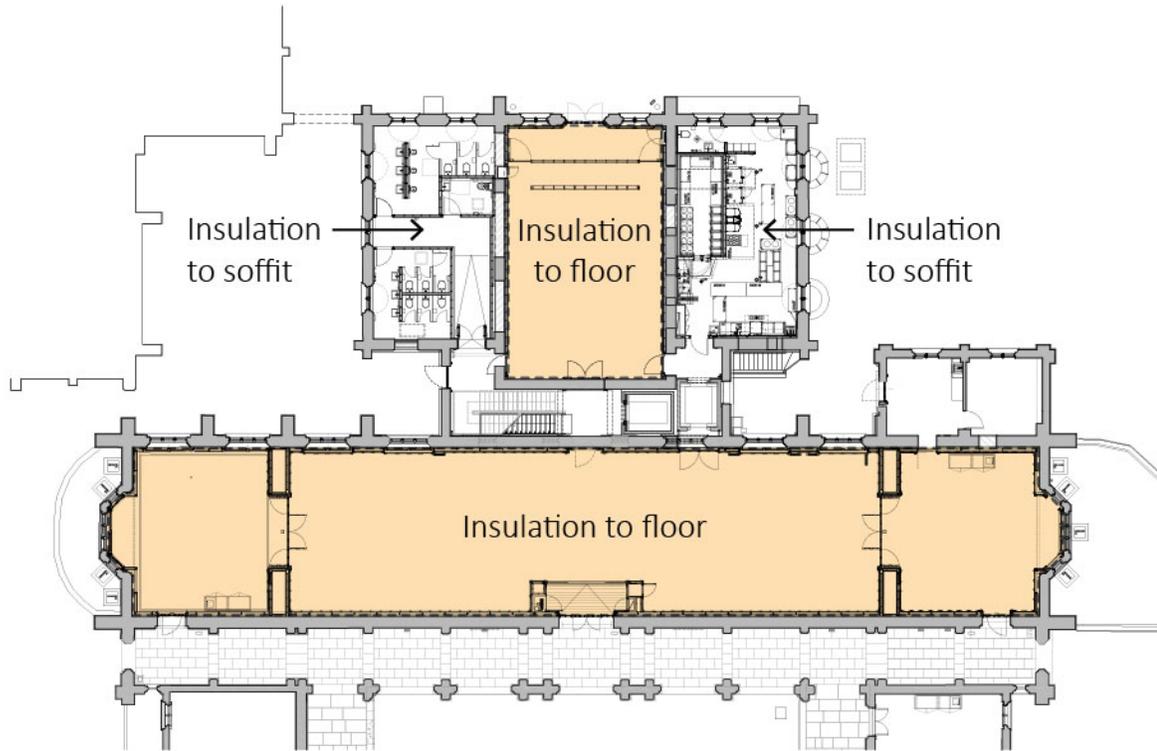
GROUND FLOOR PLAN

Internal 'compartmental' approach

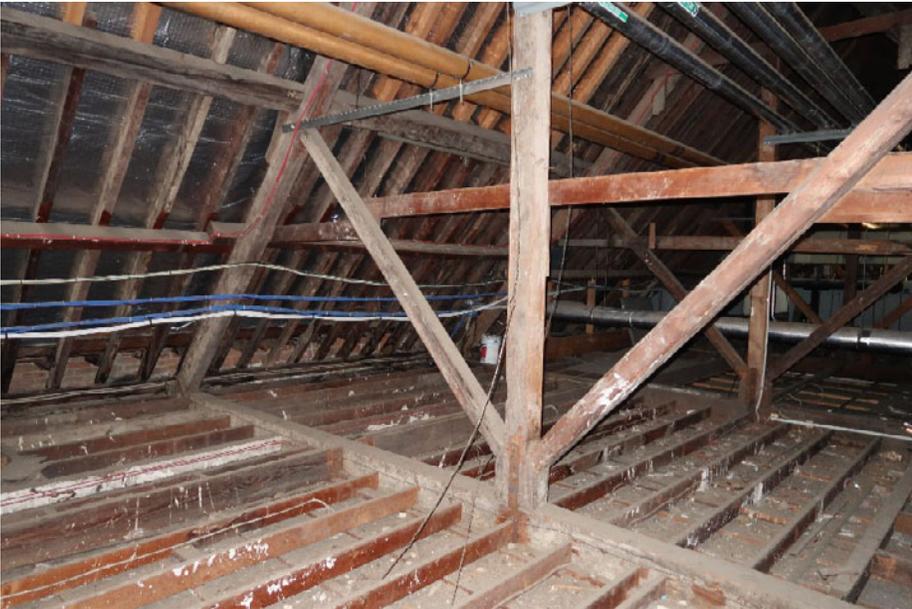
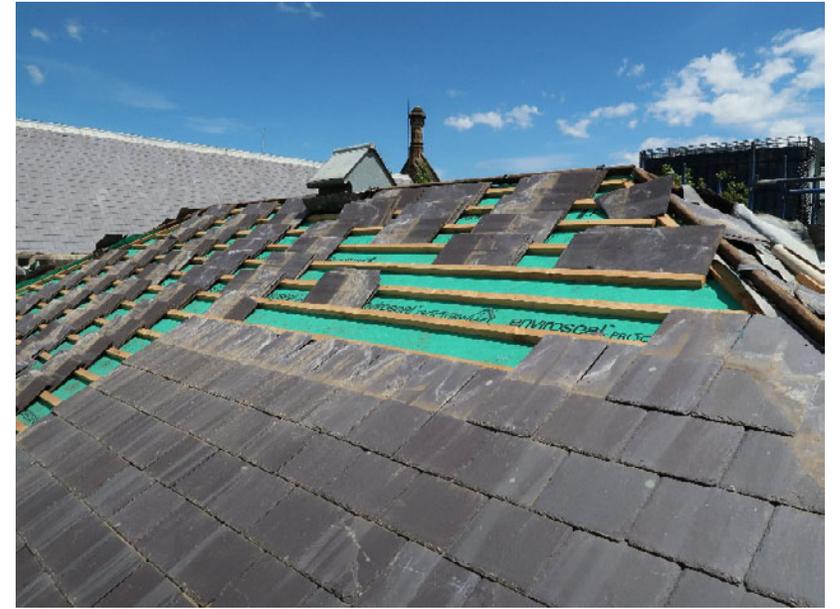
ROOFS

The roof structures are formed by transverse King post trusses in the north wing and King post arch-braced in the north annex. All trusses are connected with metal connectors, supporting under purlins, rafters, battens and slates. North wing and north annex roofs were not insulated. East wing roof was partially and insufficiently insulated.

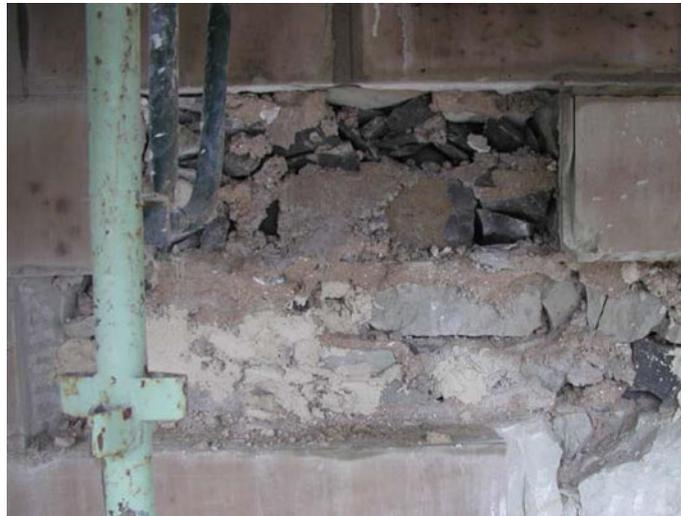
EXISTING WALLS

The east, west and north wings of the Old Quad and the north annex exhibit conventional mid-nineteenth century techniques. The load bearing external walls are comprised of rough coursed rubble faced with Kangaroo Point sandstone sourced from Bellerive, near Hobart, Tasmania, with no cavities and in the order of 400-600mm thick. All internal walls are hard plastered masonry. The basement areas of the east and west wings are brick, faced with coursed squared bluestone blocks, with details in stone and brick.

The high conductivity of the rubble and brick construction as well as original connection details where external walls meet internal walls presents significant areas of thermal bridging, with the continuation of the same construction for internal perpendicular walls in many locations.

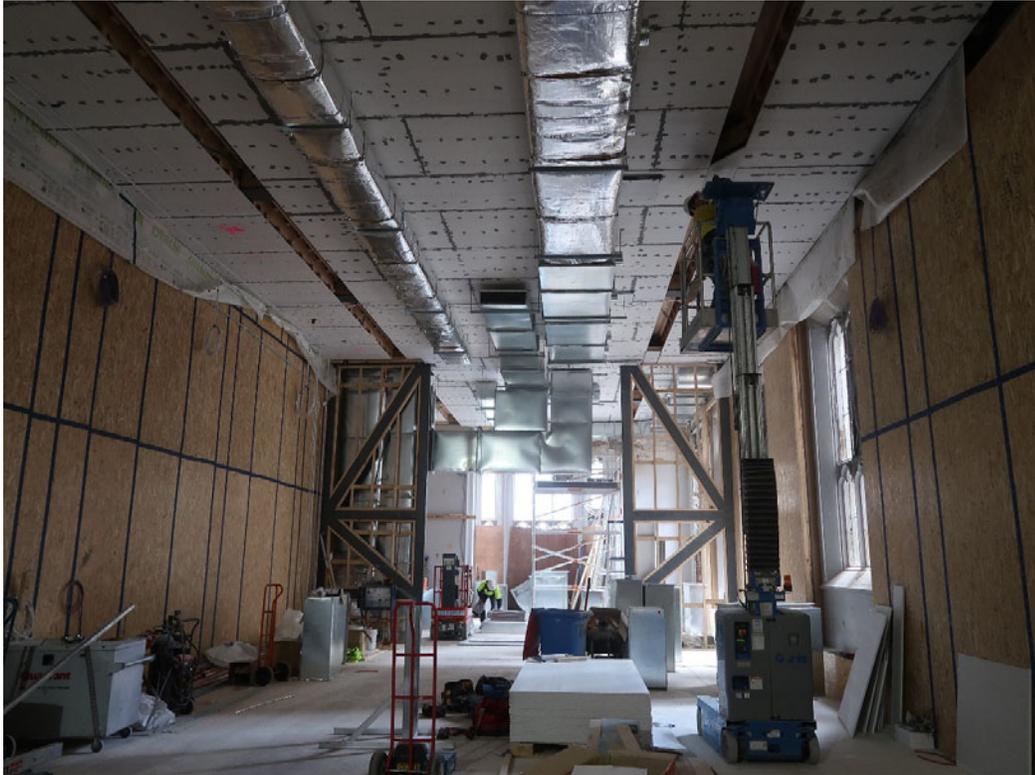
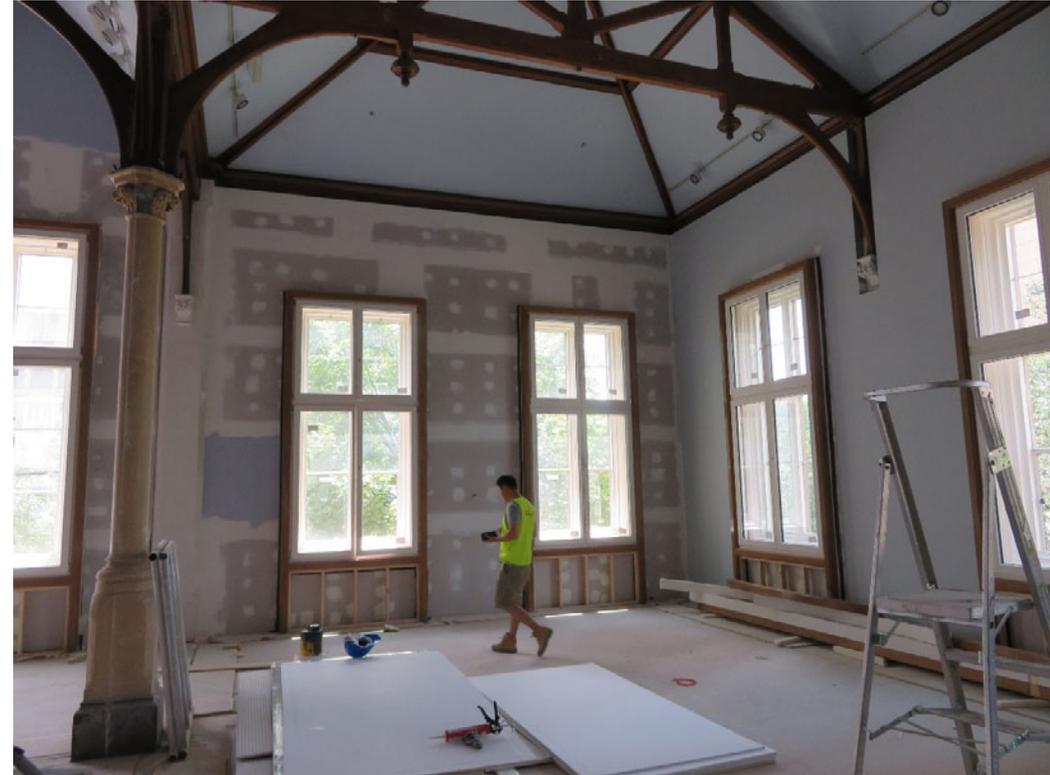
WALLS - INTERVENTION

The removal of non original floors in the north wing has enabled the installation of an internal EnerPHit envelope.

The walls in the north annex and the east wing were lined with insulated plasterboard.

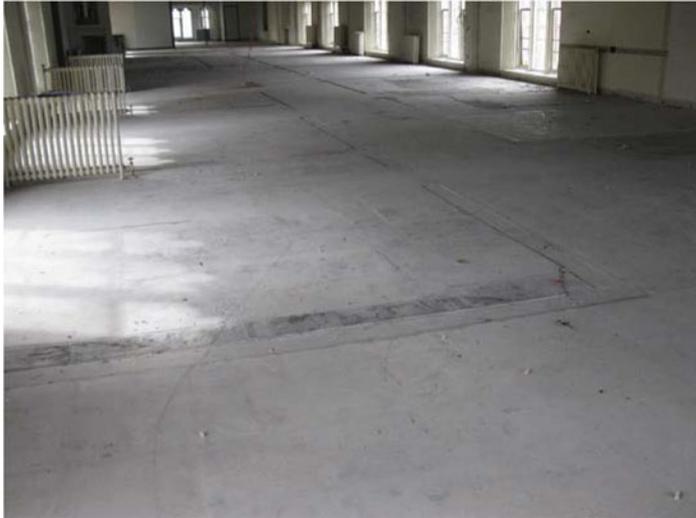
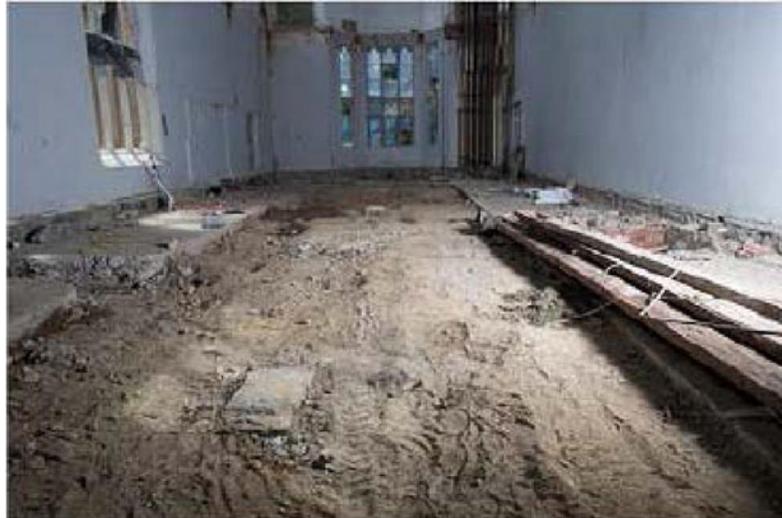
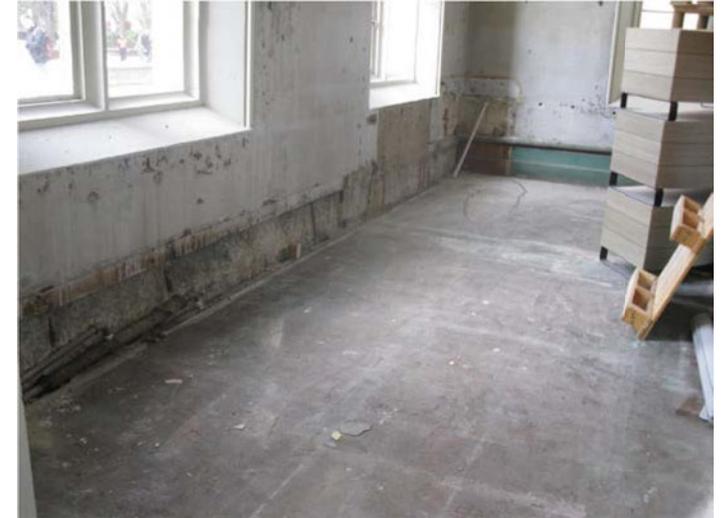
FLOORS

Perimeter thermal bridges were significant given the junction of floors with stone walls with no insulation. Original floor construction and connection details as well as external paving adjoining occupied conditioned spaces created numerous thermal bridges. The original floors are of timber joist construction with herringbone braces and tongue and groove softwood boards. The east wing first floor was constructed as separate floor and ceiling structures for acoustic separation, doubling up the thermal bridging through the floors and ceilings.

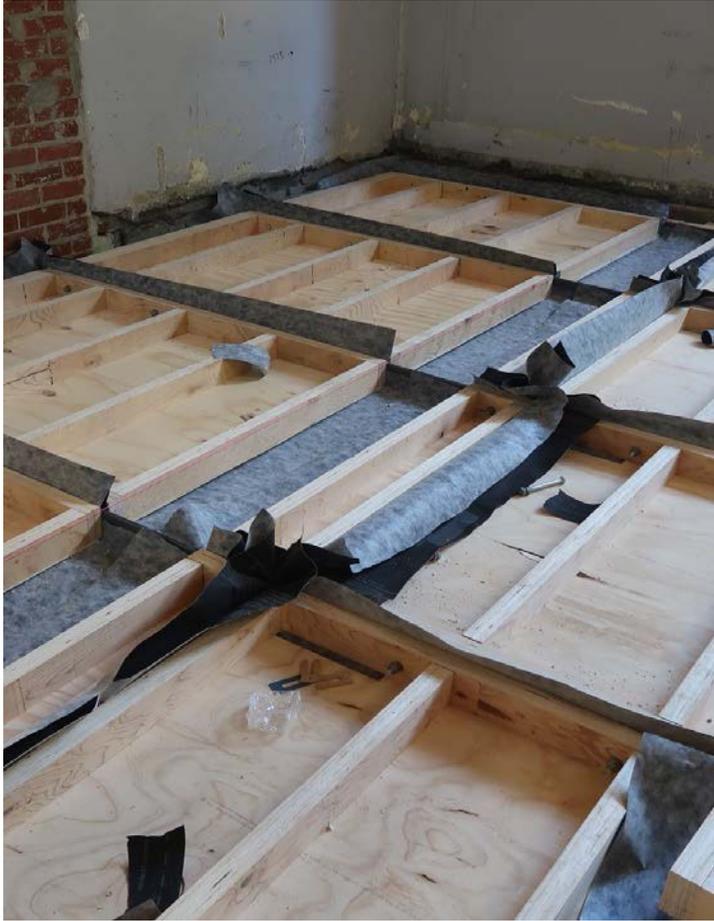
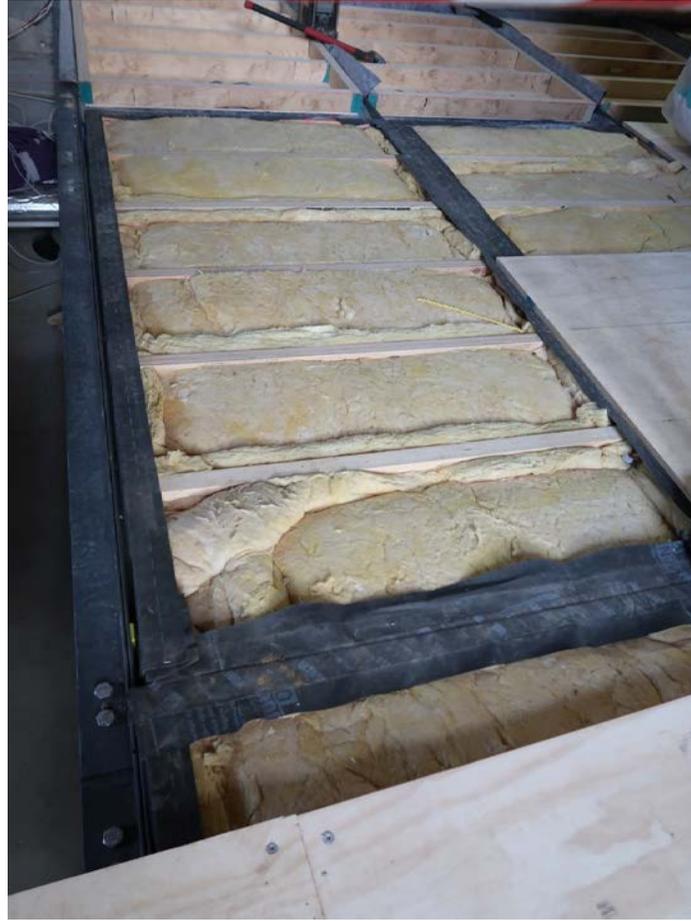
INSULATED FLOORS

North wing cassette system pre-fitted with vapour permeable membrane and filled with insulation.

Floors during construction

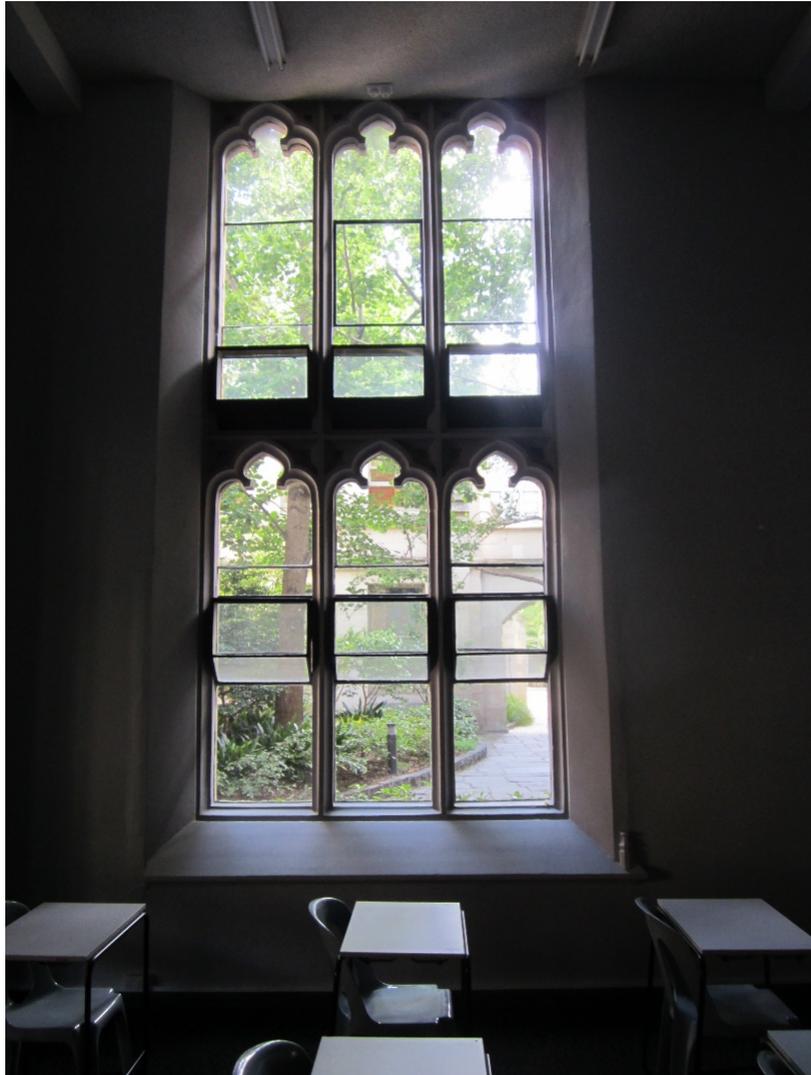
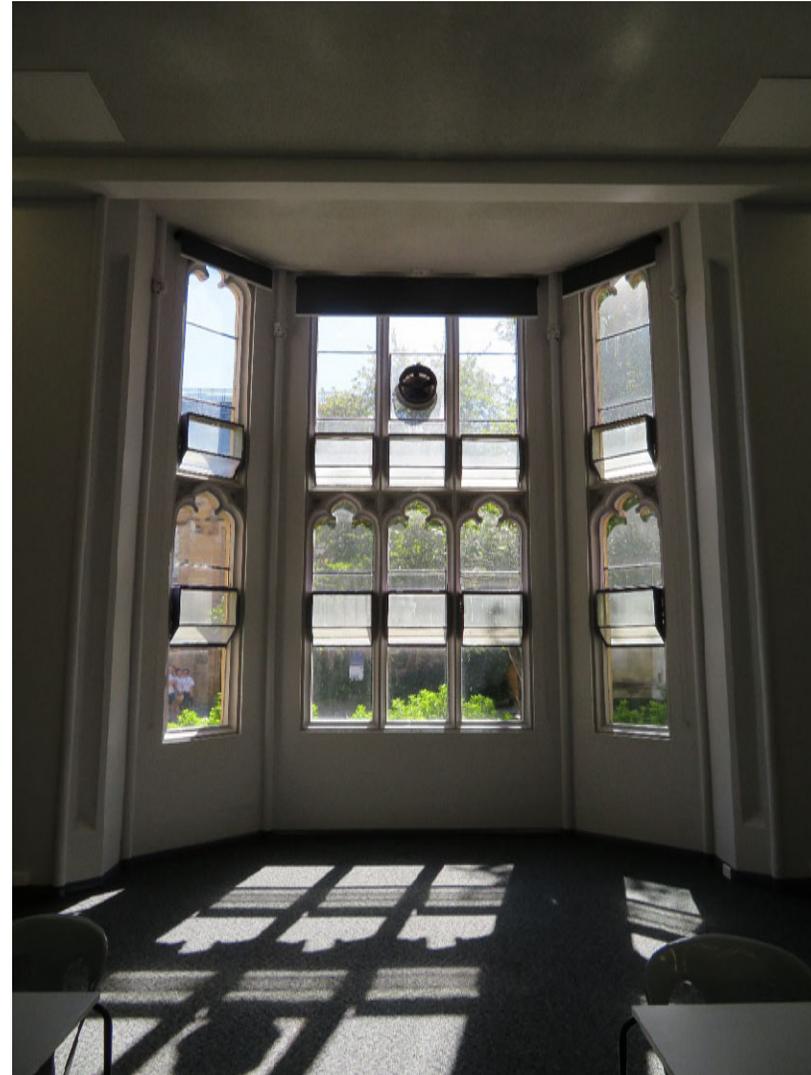
EXISTING WINDOWS

- Existing glazing - 3-4mm clear float glass, mounted within a range of framing systems including stone, steel and timber (very poor thermal and solar performance)
- According to Umov Lai analysis the total system U-values are likely to be $\geq 7.0 \text{ W/m}^2\text{K}$, with high solar heat gain coefficients (0.75–0.88) resulting in substantial heat loss through the single glazed steel and timber windows
- Several options were considered including:
 - > fitting new single, double and triple glazed units into the existing frames; or
 - > installing new frames in the existing stone tracery to the north wing and annex.

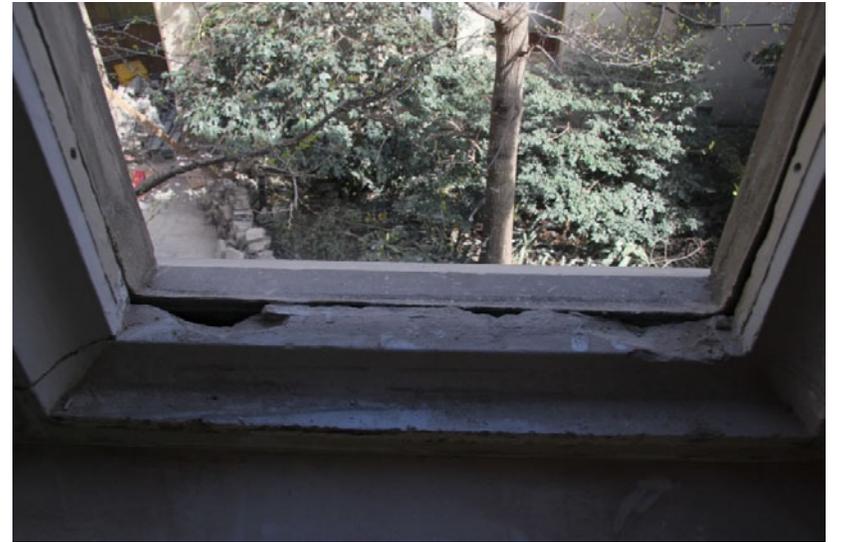
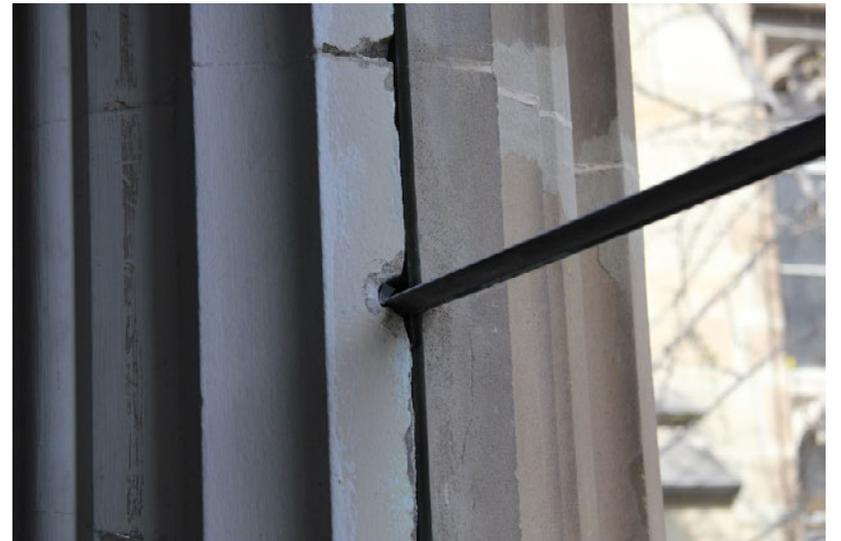
HIGH PERFORMANCE SECONDARY WINDOWS

Refurbishing and retaining the existing windows and adding a secondary layer of windows to the inner skin walls was the adopted strategy, with openable windows to allow for maintenance and cleaning of internal surfaces.

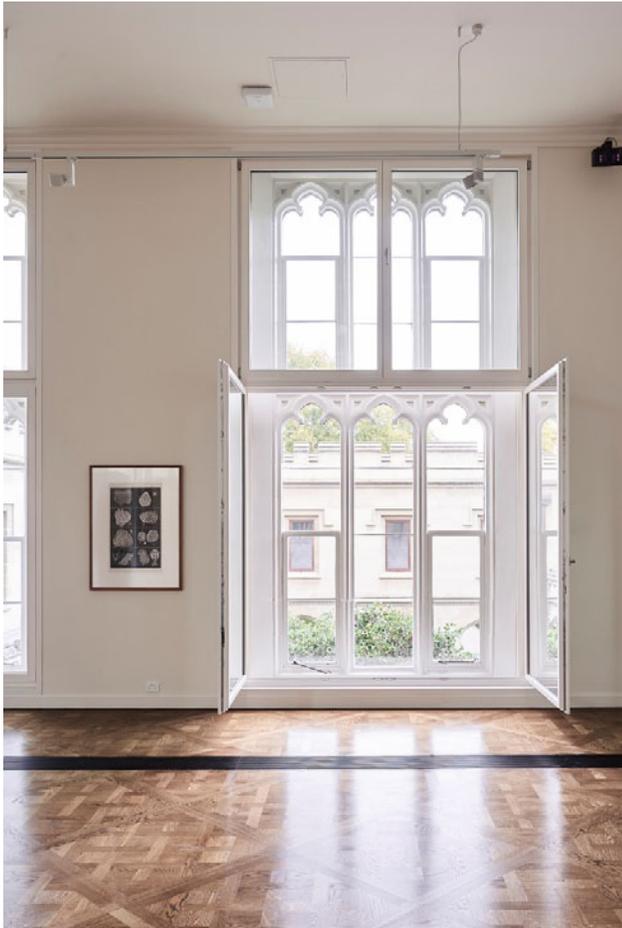
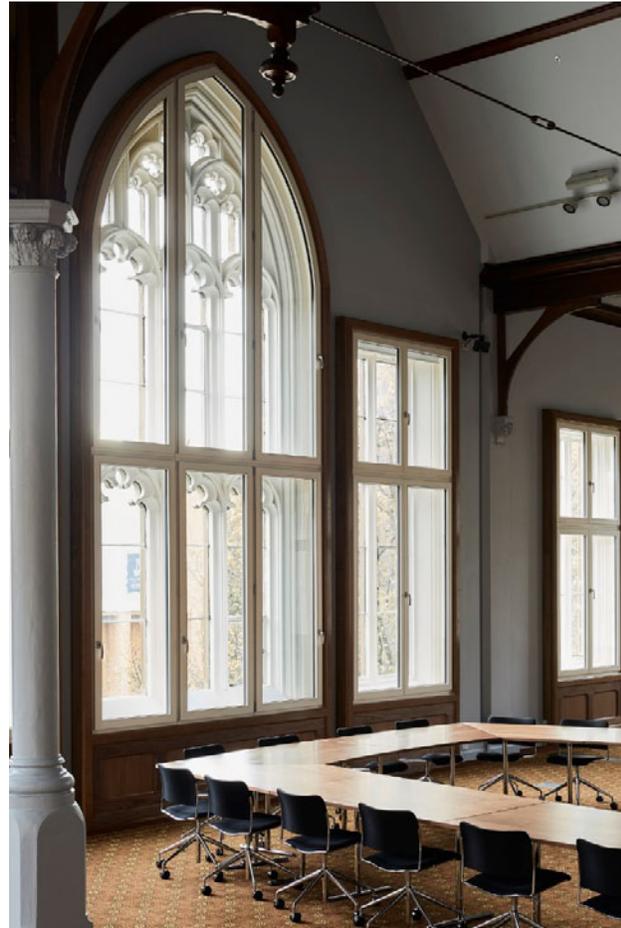
*Secondary layer of openable windows
Source: Eve Wilson (photographer)*

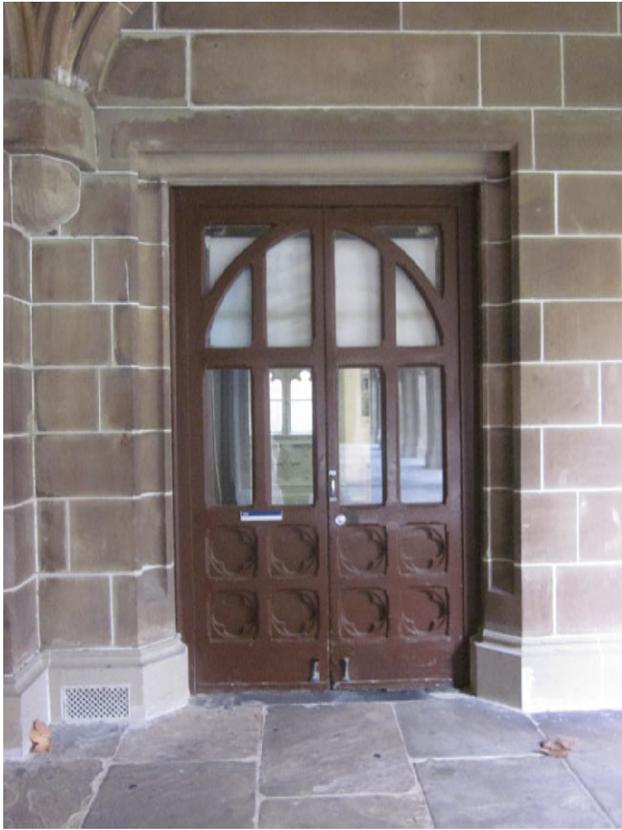
Original door

Remaining original door details were used for the design of the new doors.

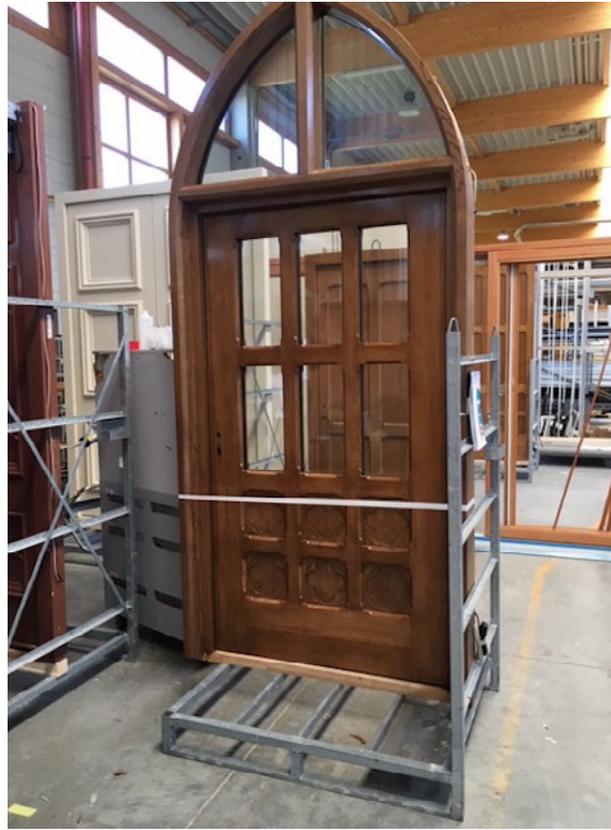
New high performance doors prior to installation

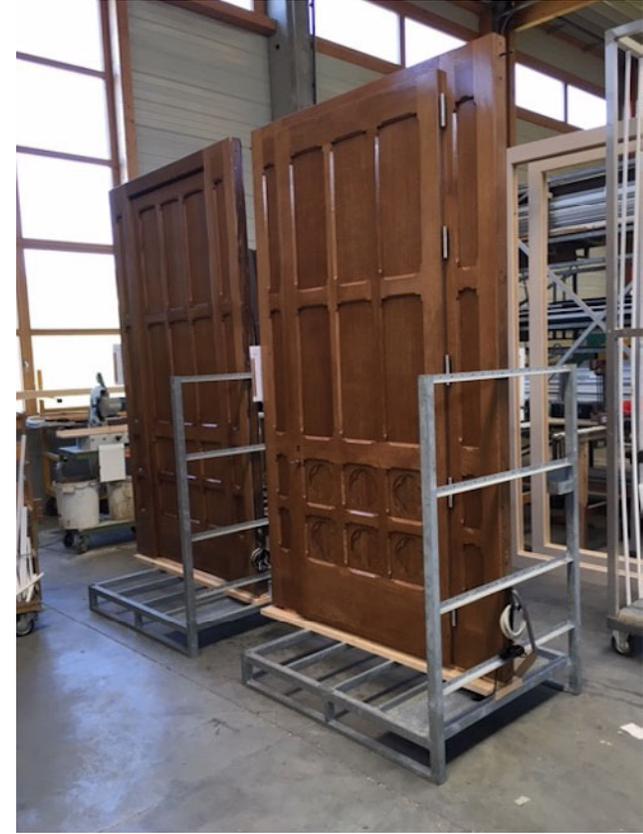
DOOR PERFORMANCE

Performance of the windows and doors was verified by the suppliers

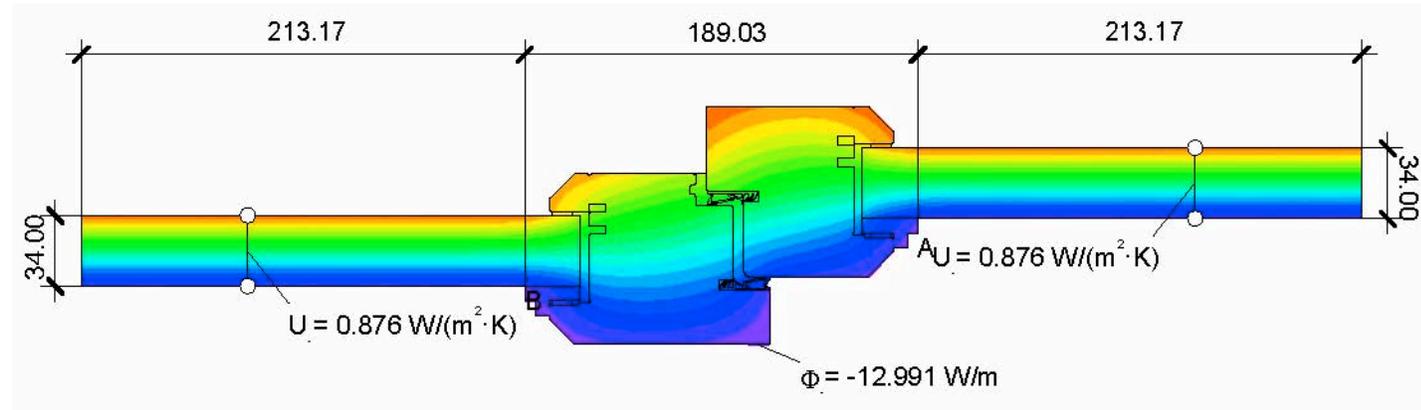
Door NNDG18 – Silber Premium Windows and Doors – Source: Laros Technologies

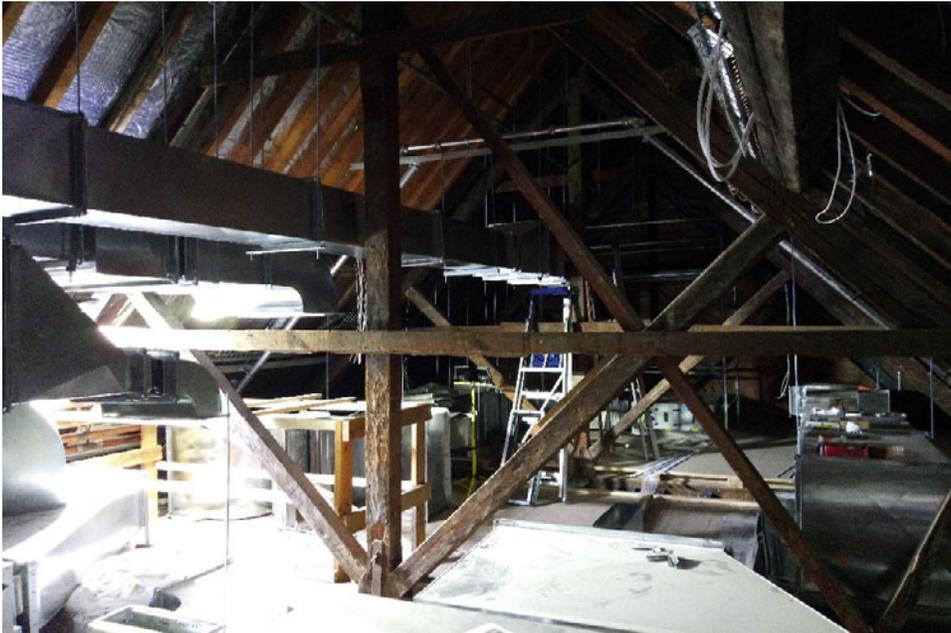
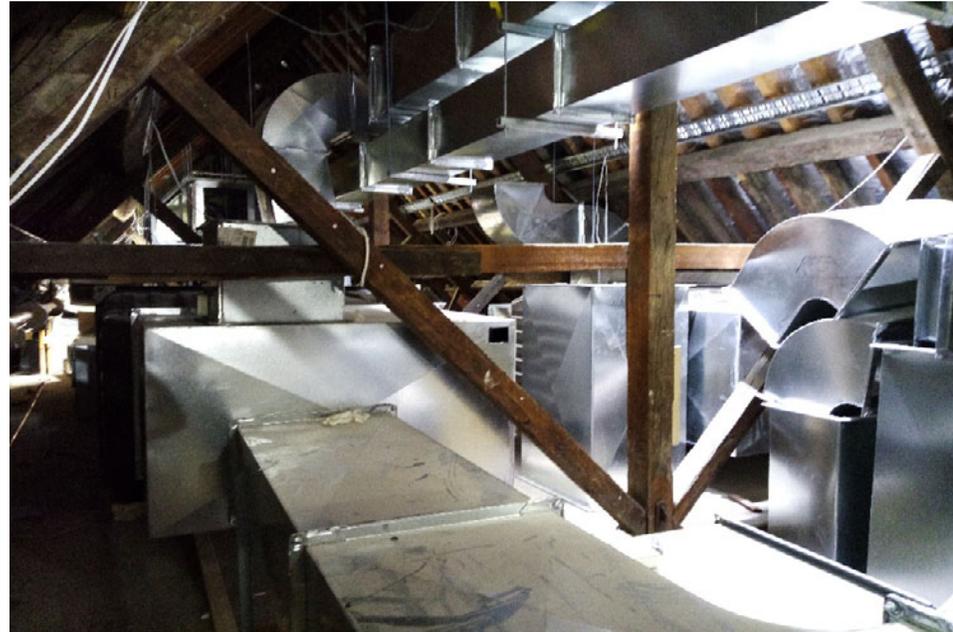
The mechanical plant is concealed predominantly in the gable roof to the north wing with some units and ductwork installed in the floors and ceilings of the north wing and annex. Critically for the Old Quad project, a conventional mechanical system would require significantly larger plant including a chiller and associated infrastructure works to be installed in an adjacent building. This was eliminated by using EnerPHit.

Ventilation system, during installation in the north wing roof

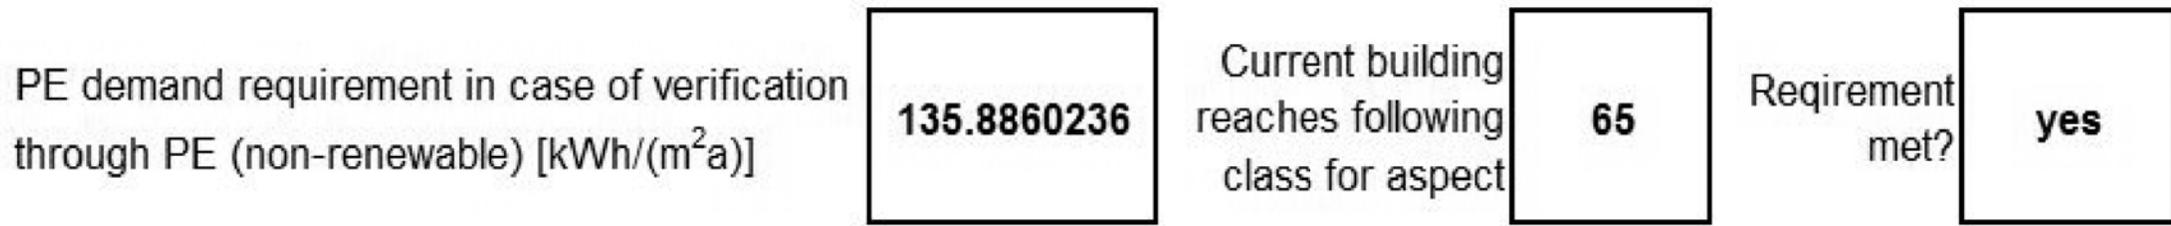
Annual heating demand is calculated but is not used for verification using the Component method. All building services are treated within the scope of EnerPHit for the purposes of Primary Energy demand calculation.

Primary energy demand requirement, verification through PE, from EnerPHit PHPP V9.3a

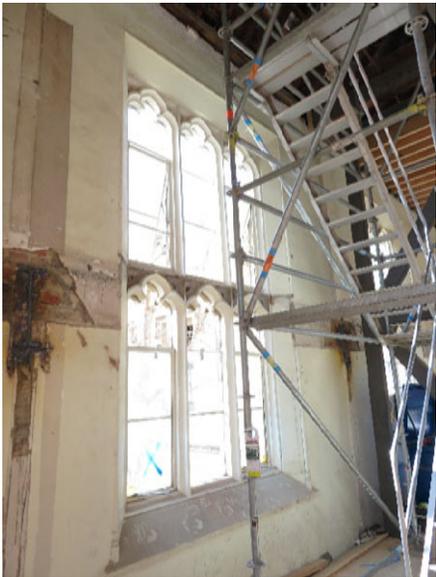
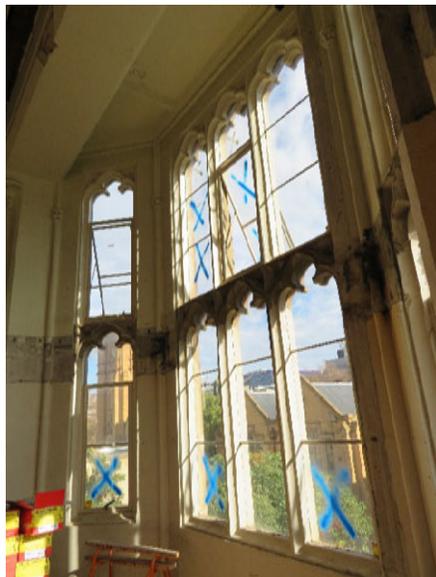
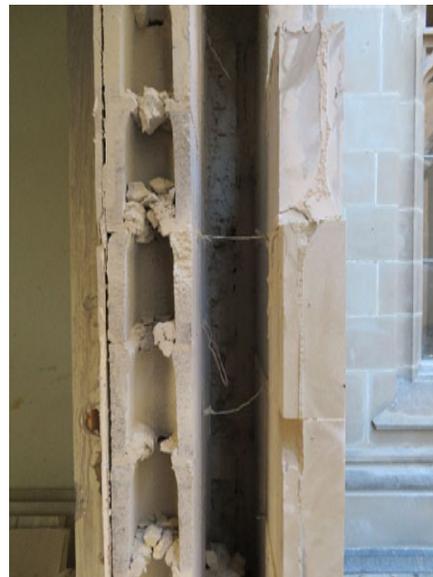
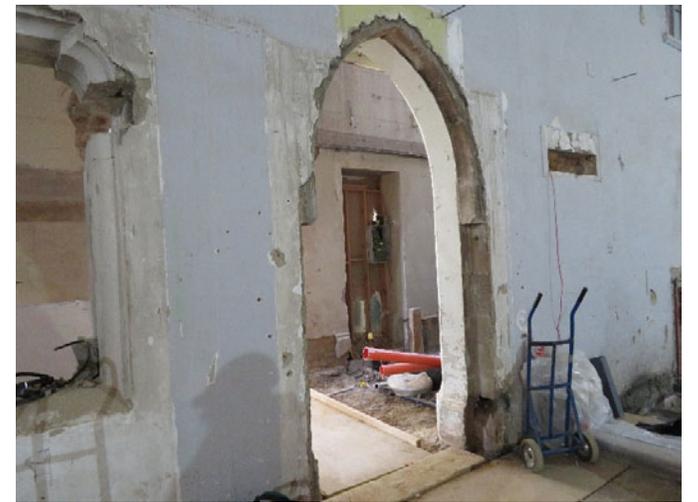
SURFACE CONDENSATION ASSESSMENT

To mitigate this risk the documentation underwent a surface condensation analysis, hygrothermal assessment and thermal bridging assessment carried out by Inhabit using THERM 7.4. and WUFI Pro 6.1. The analysis highlighted that surface condensation is predicted to form on the internal surface of the existing single glazing and framing when the external temperature drops below 12°C.

From the very beginning there were concerns that improvement of the external wall thermal performance by adding internal insulation would change the transfer of vapour through the walls and create moisture and condensation problems. When the building is insulated internally the 'breathing' of the building changes and the risk can be the creation of cold bridges leading to condensation and mould growth.

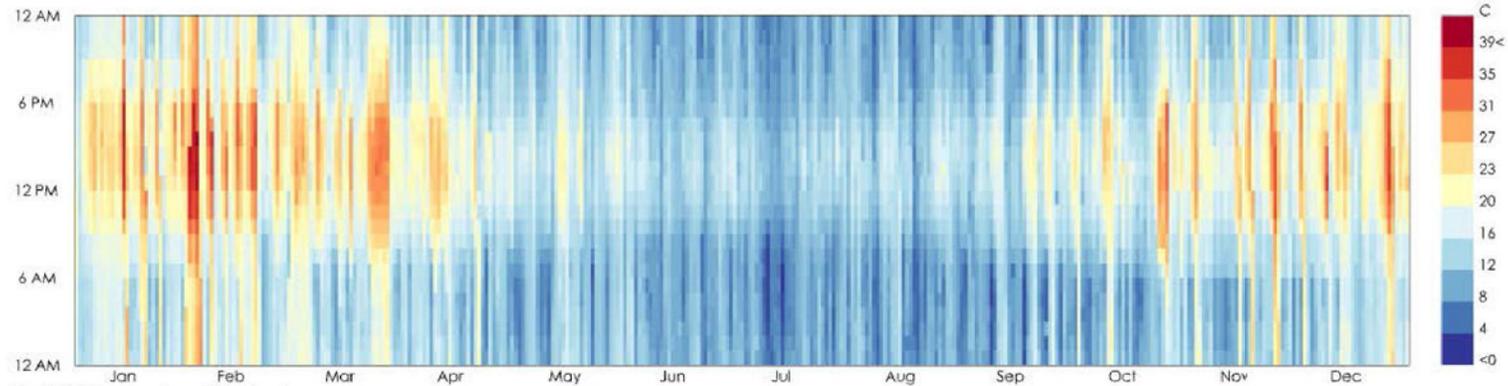
Dry Bulb Temperature (C) - Hourly
MELBOURNE_AUS
1 JAN 1:00 - 31 DEC 24:00

Annual External Dry Bulb Temperature ($^{\circ}$ C) and Relative Humidity (RH), Melbourne – Inhabit.

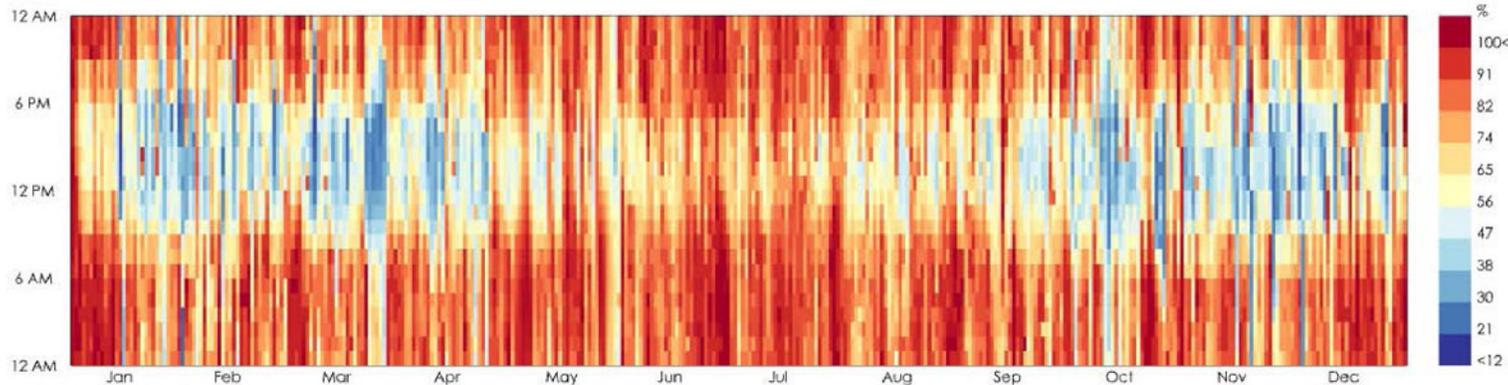
Relative Humidity (%) - Hourly
MELBOURNE_AUS
1 JAN 1:00 - 31 DEC 24:00

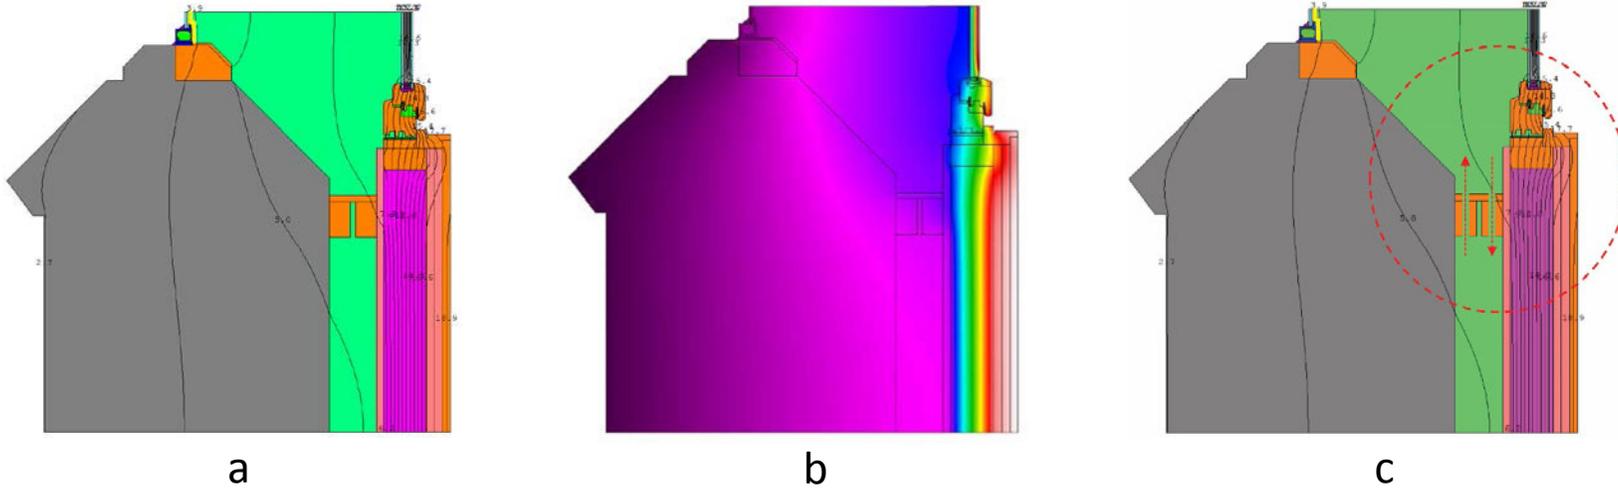
The risk associated with the build-up of condensation in the airgap was resolved by providing vertical circulation of the air through the perimeter cavity of affected walls

- a) *THERM Isotherm Result;*
- b) *b) Colour Infrared Result;*
- c) *c) Adopted solution with introduced ventilation.*

External Wall Type - north wing – THERM Isotherm and Colour Infrared Result and proposed ventilation - Inhabit
