The Old Quadrangle

Retrofitting a significant heritage building to Passive House EnerPHit standard

University of Melbourne, Parkville VIC

October 2019

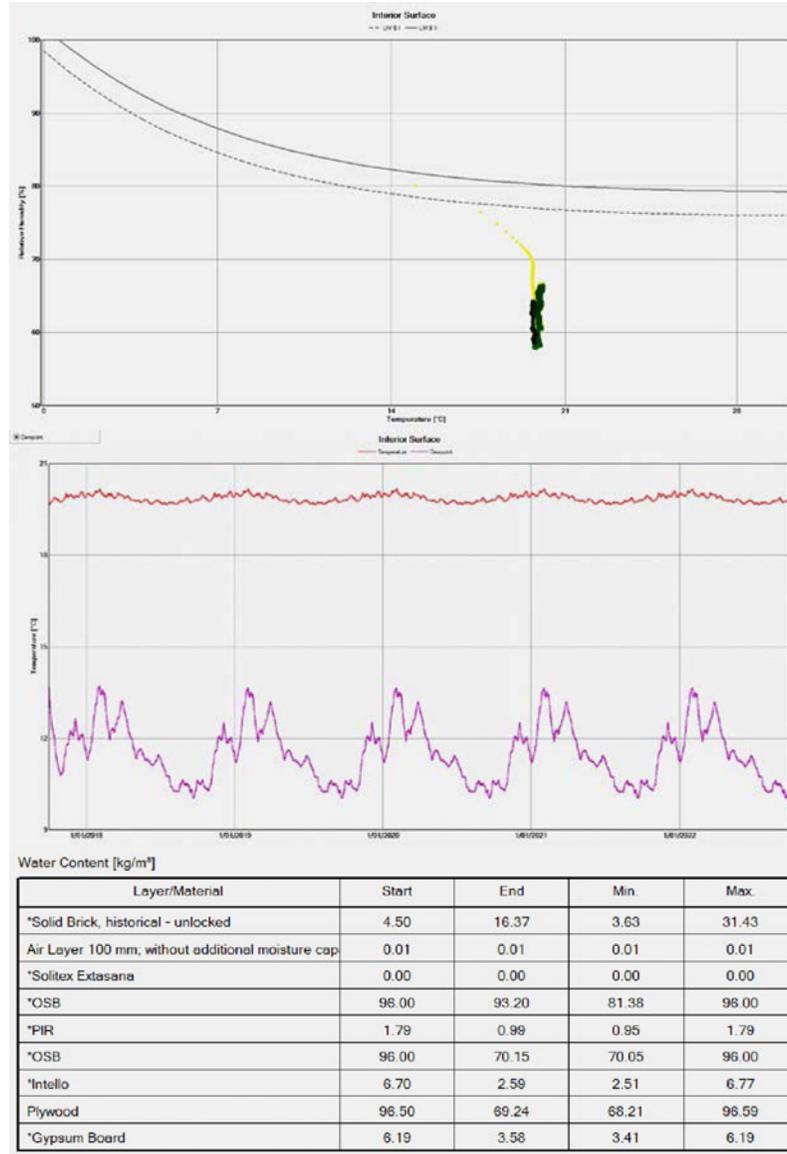
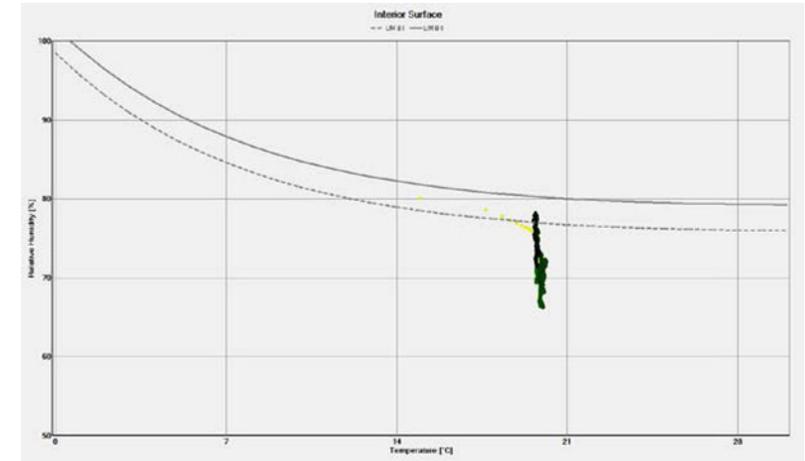
Interior surface temp (°C)/relative humidity (%), without Intello membrane – Inhabit.

Walls- north wing – Interior surface temperature (°C) relative humidity (%) (above) And water content (kg/m³) – Inhabit.

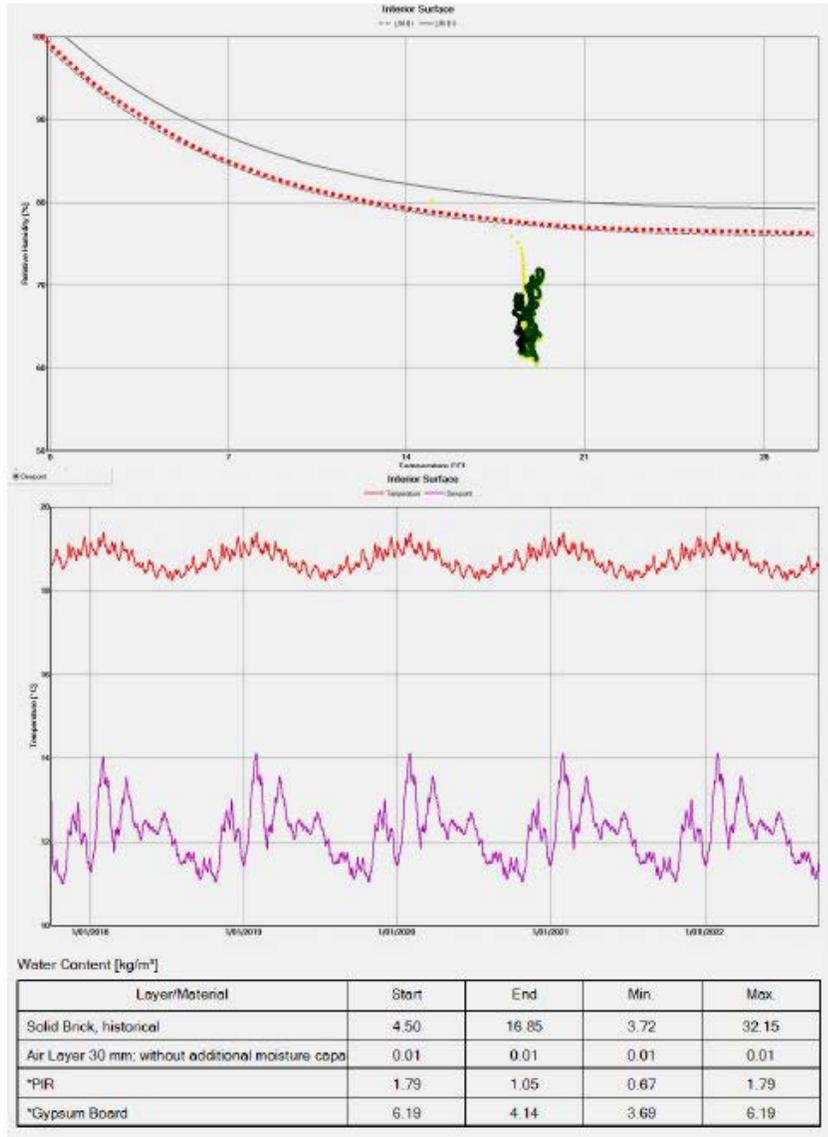
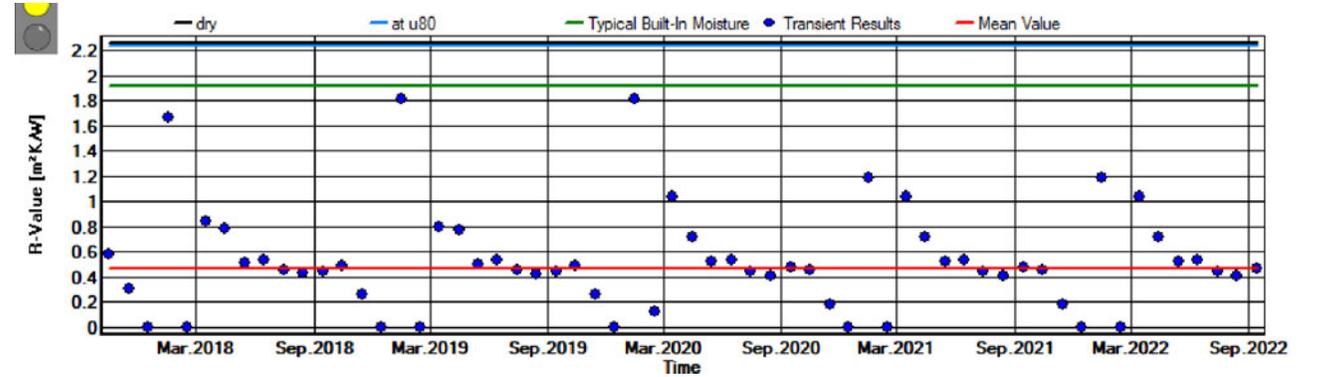
b) Annualised Wet R – value Variation– Inhabit.

a) Walls- north annex – Interior surface temperature (°C) relative humidity (%) (above) And water content (kg/m³) – Inhabit.

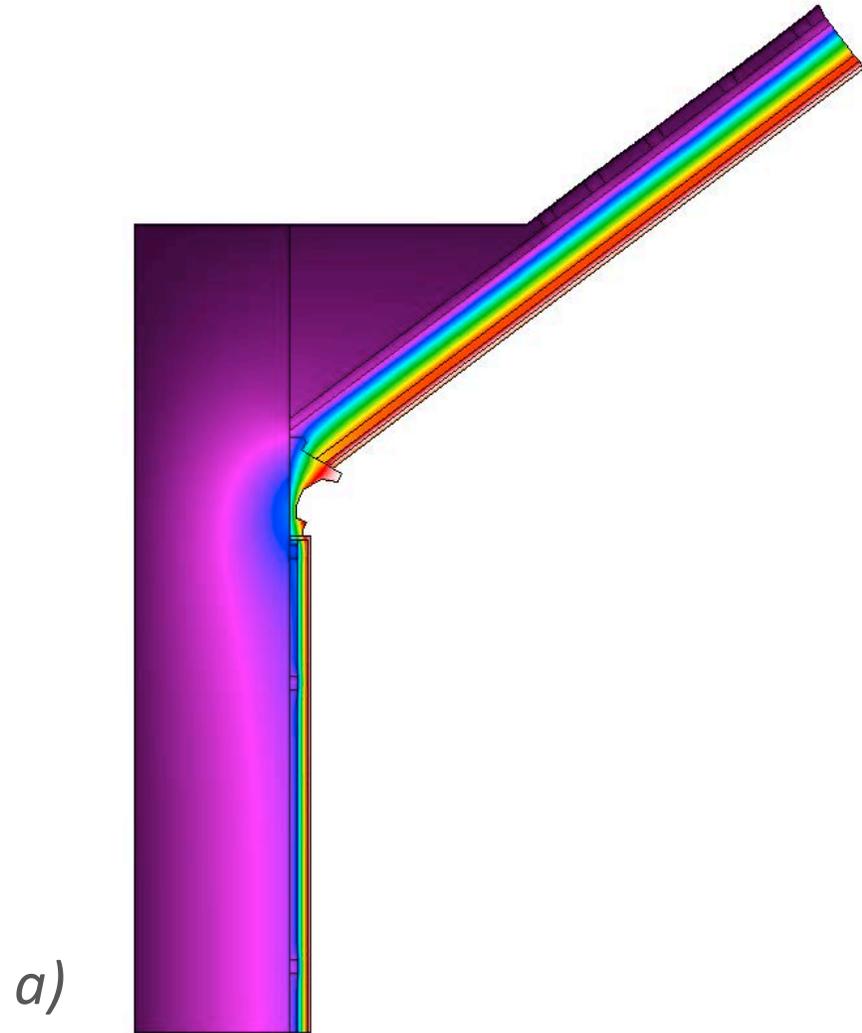
a) *THERM Isotherm Result;*
b) *Colour Infrared Result;*

Library roof – THERM Isotherm and Colour Infrared Result - Inhabit

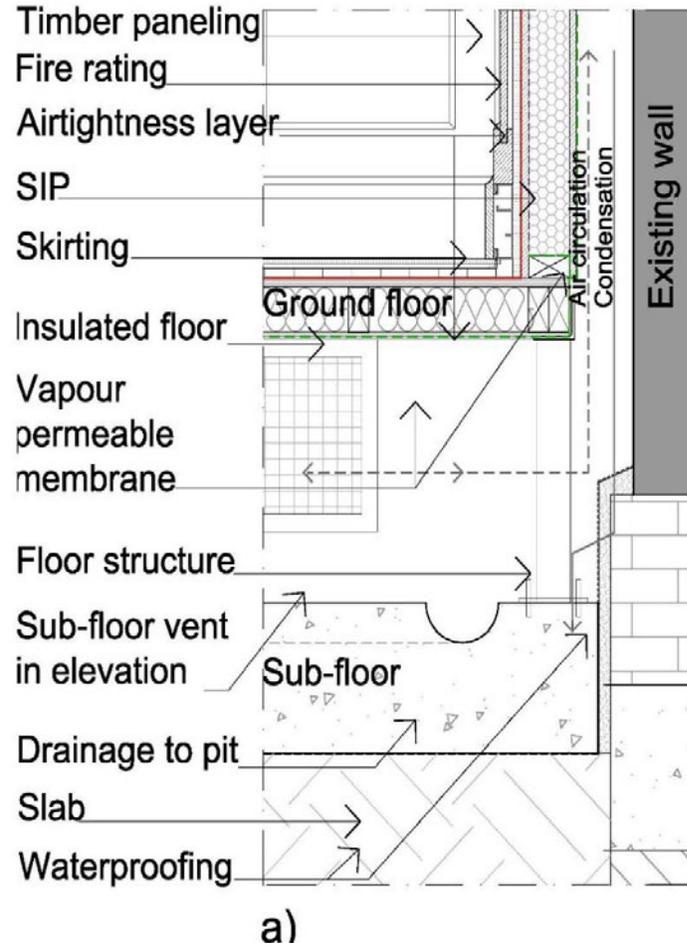
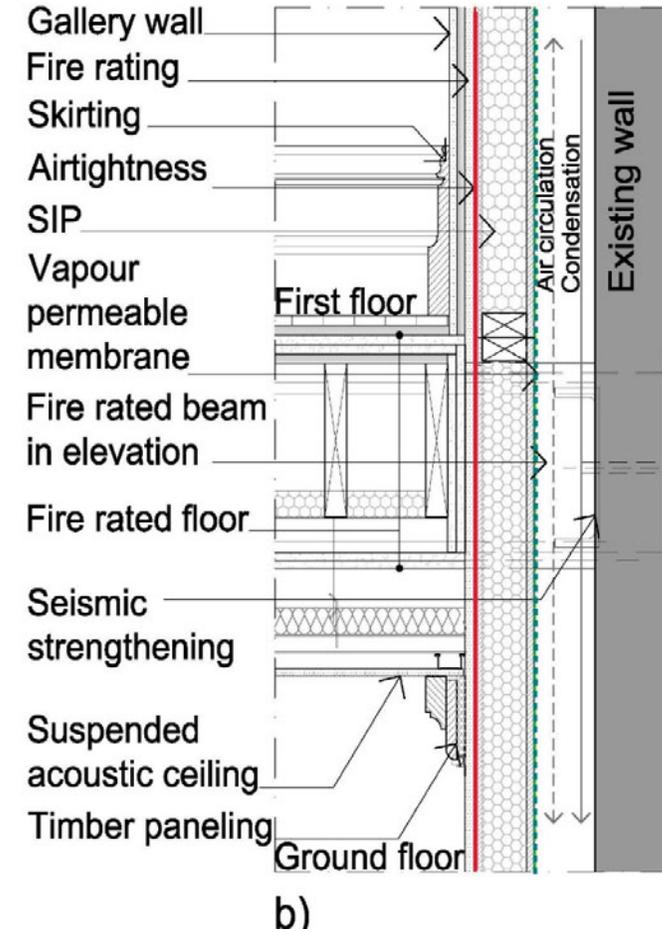
Typical wall connection details in north wing. a) Sub-floor and wall junction; b) First floor and wall junction; c) Roof and wall junction.

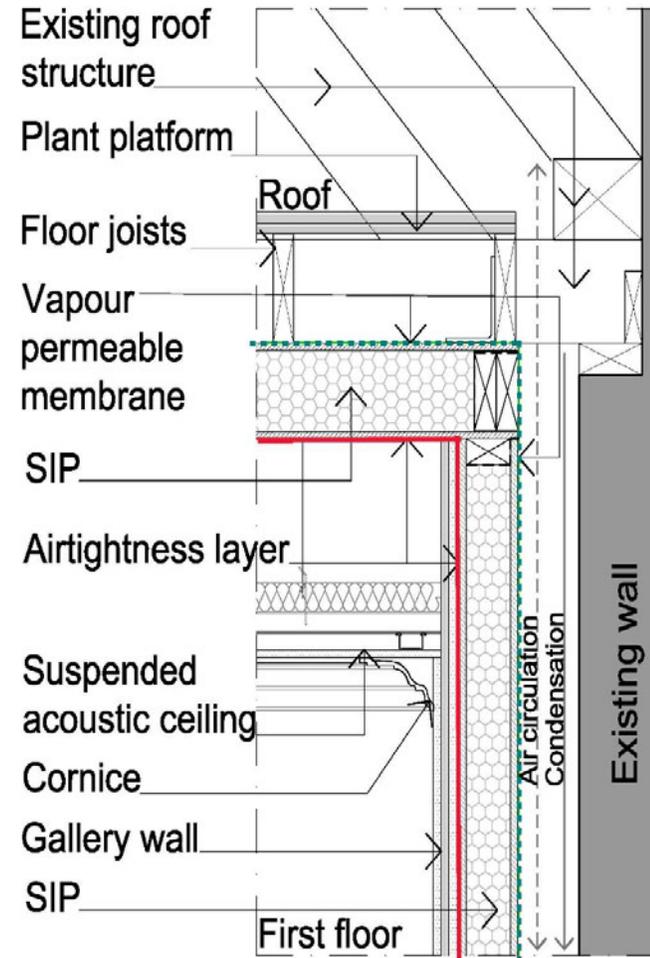
Typical wall connection details in north wing. c) Roof and wall junction.

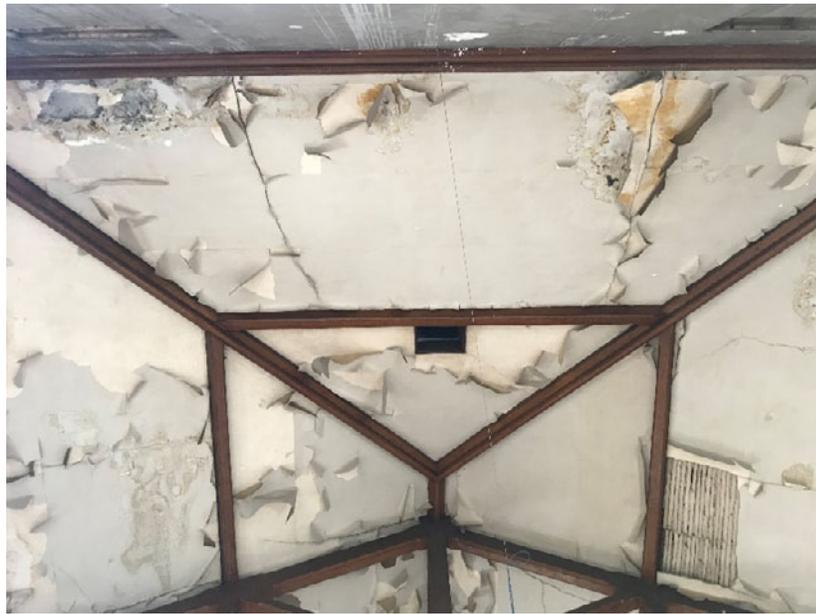
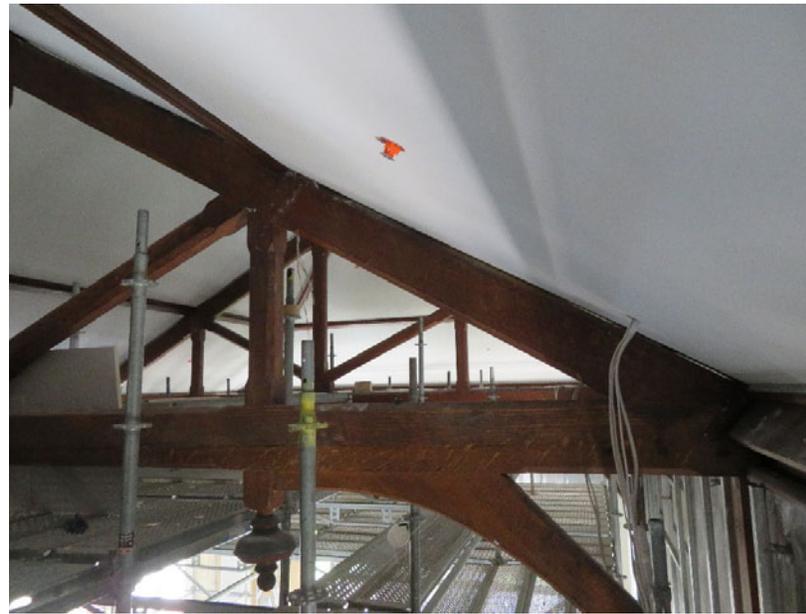
AIRTIGHTNESS APPLICATION

Three interim, airtightness pressurization tests were conducted for the north wing to date achieving n_{50} 1.11 1/h and n_{50} 1.04 1/h and n_{50} 2.03 1/h, respectively. One test was conducted for the library achieving n_{50} 3.73 1/h.

The interim reports have identified several defects related to the airtightness of penetrations of the services as well as defects related to sealing of the new structures around the existing timber trusses. Defects rectification related to the airtightness including the final pressurisation test are scheduled for November 2019.

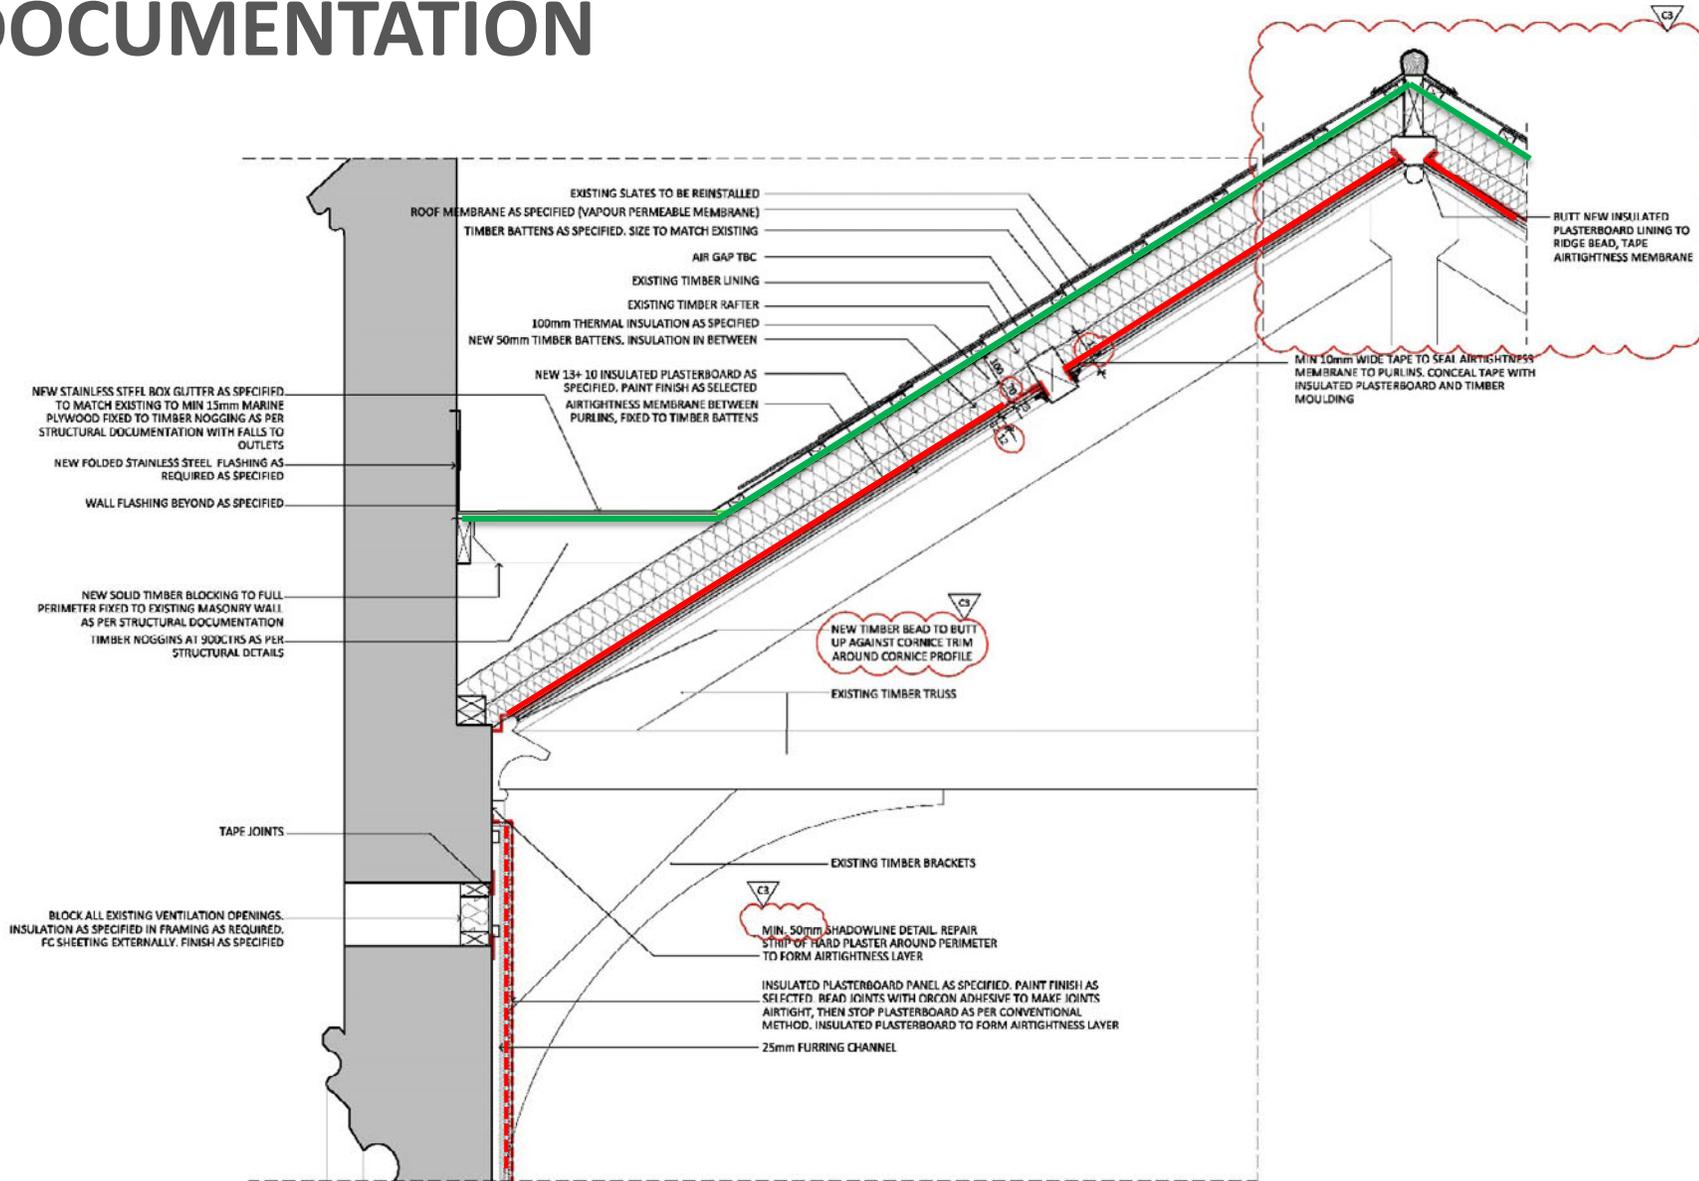
- Nominated material to form airtightness layer (i.e. plywood, render, insulated plasterboard)
- Airtightness membrane, all joint taped
- Vapour permeable membrane, all joints taped
