**PARAFIELD AIR  
TRAFFIC CONTROL  
TOWER NO. 2**

HERITAGE  
MANAGEMENT PLAN

August 2018

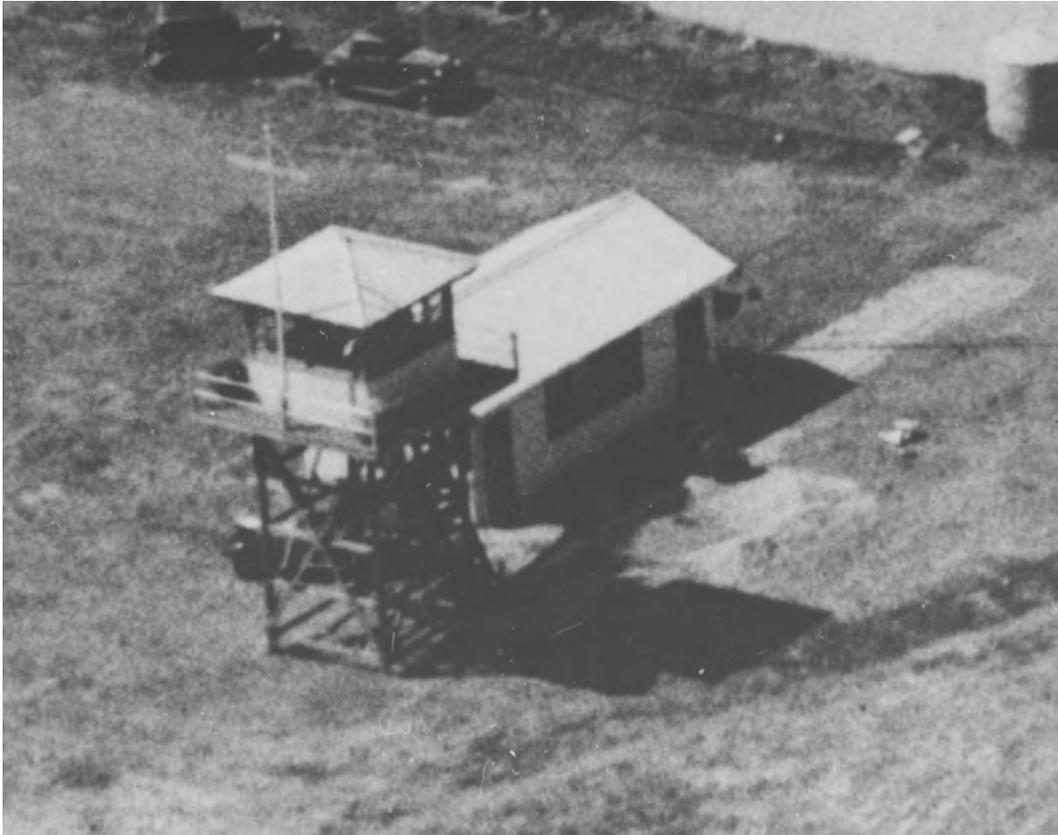
Figure 10 Parafield's ATC tower no. 1, built in 1937

The ATC tower no. 1 at Parafield was constructed in 1937 and was a two-storey timber-framed base supporting a pyramidal roofed cabin surrounded by an external balcony (see Figure 10). By the time of its construction, Parafield was handling regular passenger services to and from Perth, Melbourne and Sydney, as well as inland centres.<sup>40</sup> Although no early plan of the airport has been located, Figure 11 shows the location of Parafield’s ATC Tower no. 1 near the end of Anderson Drive in more or less, the same location as the replacement ATC Tower no. 2 (the current tower).

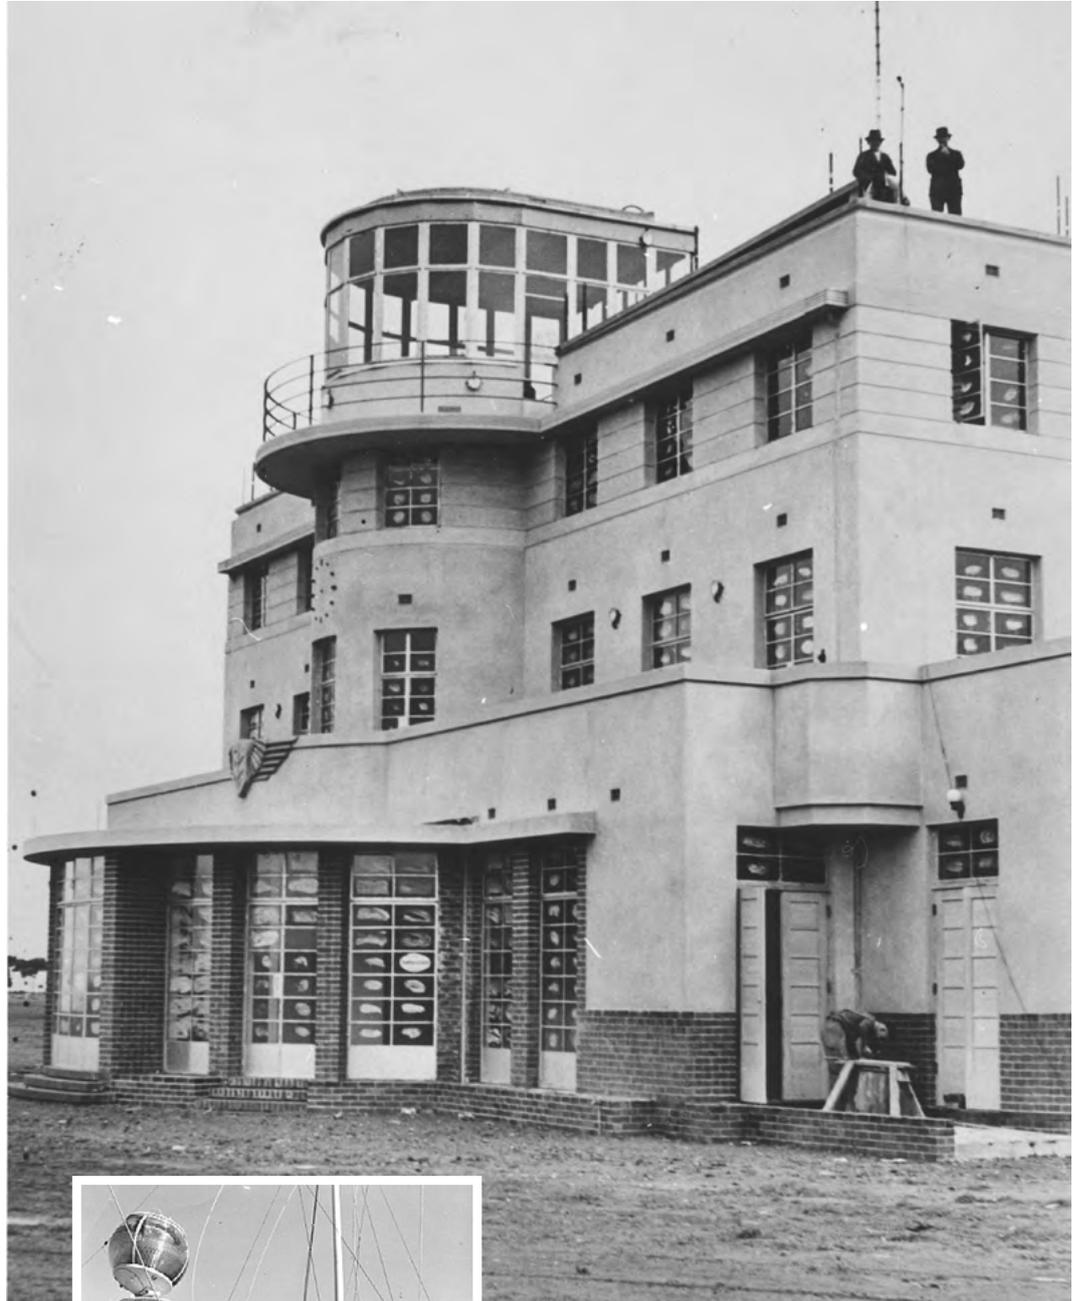
Figure 15 The rear of the original ATC tower cabin on ATC no.2, c.1941 (note the cane signalling balls in the centre of the image)

Initial communication with aircraft was via visual aids, including flags, flares and large cane balls (yellow and black) mounted on a rooftop flagstaff (Figure 15).<sup>46</sup> The controllers were also equipped with radio facilities to co-ordinate activities on the ground and to communicate with airfields locally and on routes between airfields. (See Figure 21) The tower was not fitted with radio communication until 1948.<sup>47</sup>

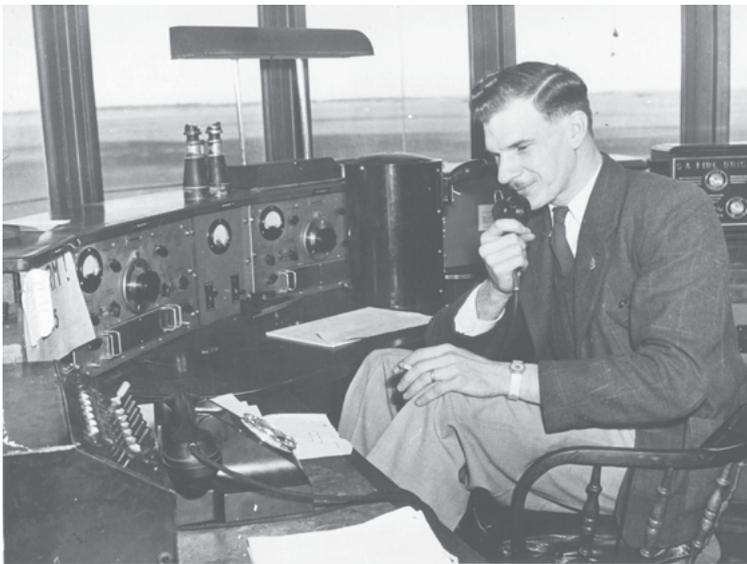
Figure 21 Interior of the original Parafield control cabin, 1947

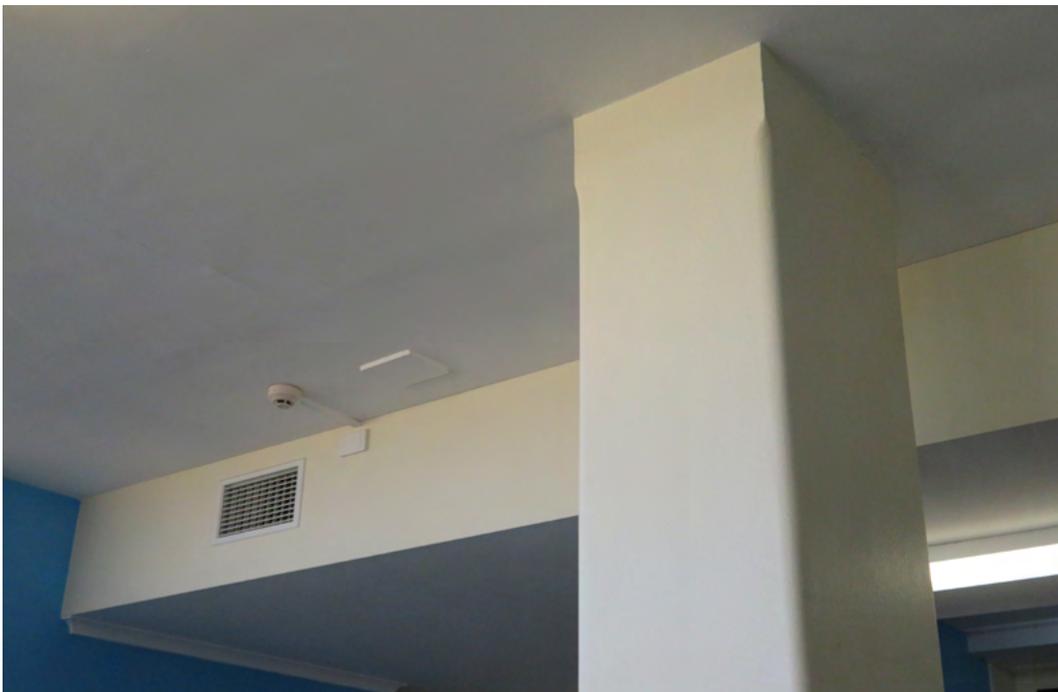
Figure 32 Original concrete-encased steel columns with modern air conditioning plenum to its rear, 2017

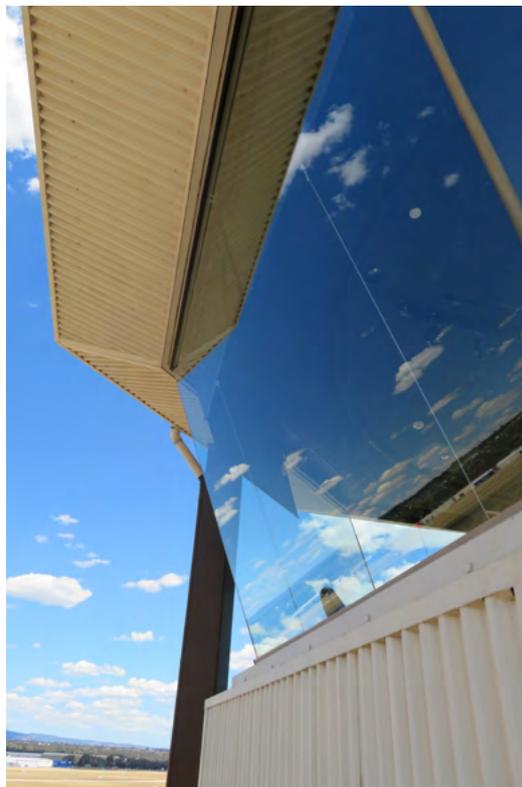
Figure 52 Glazing to cabin at left; modern external stairs to cabin levels at right, 2017

As noted, in 1981 the original ATC cabin was removed and replaced by a new octagonal cabin above a new amenities level on a square plan, both constructed on the flat roof of the three-level brick structure below. Both levels are of steel-framed construction with Colorbond® steel cladding at the amenities level with glazing to the tower. The frameless windows of the cabin are sealed with silicone. They are slanted to reduce internal reflections. Four external columns support the roof at the centres of four of its eight sides. A roof deck is provided above the cabin. Railings to the roof are constructed of steel tubing. There is ductwork and plant on the cabin roof, in addition to the usual crown of antennae and lightning conductors.

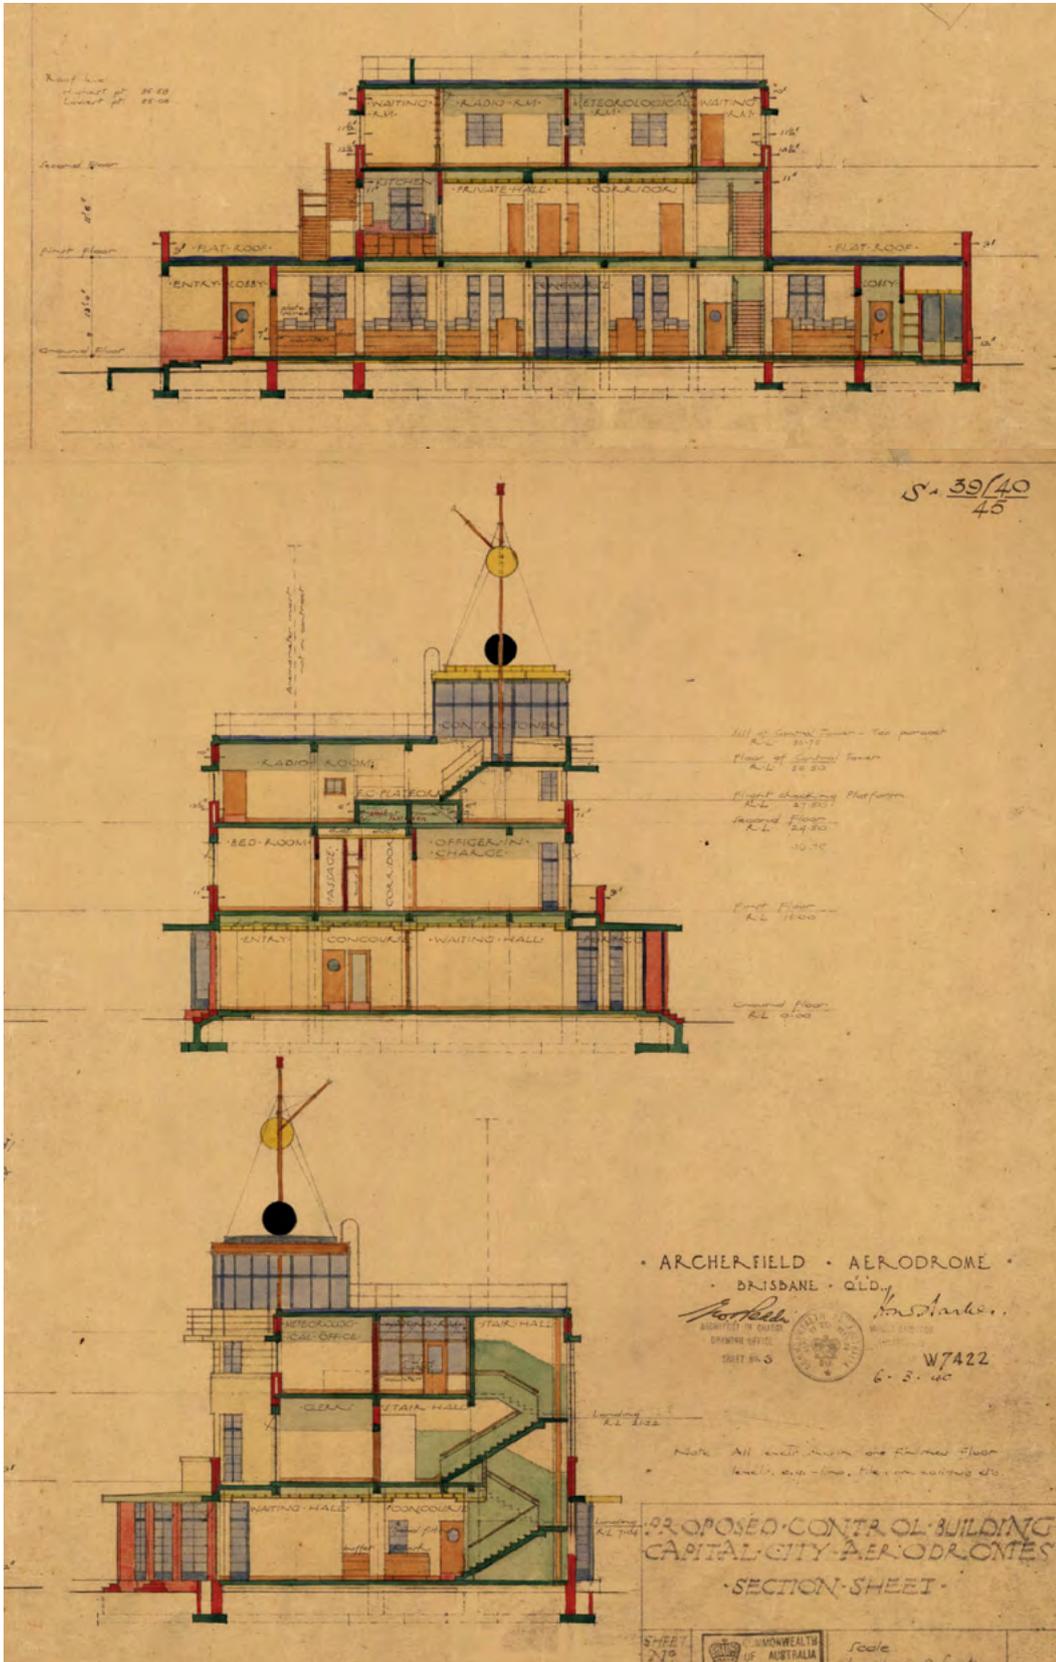
Figure 65 Elevations of Archerfield (Queensland) Ops & Admin building, 1939

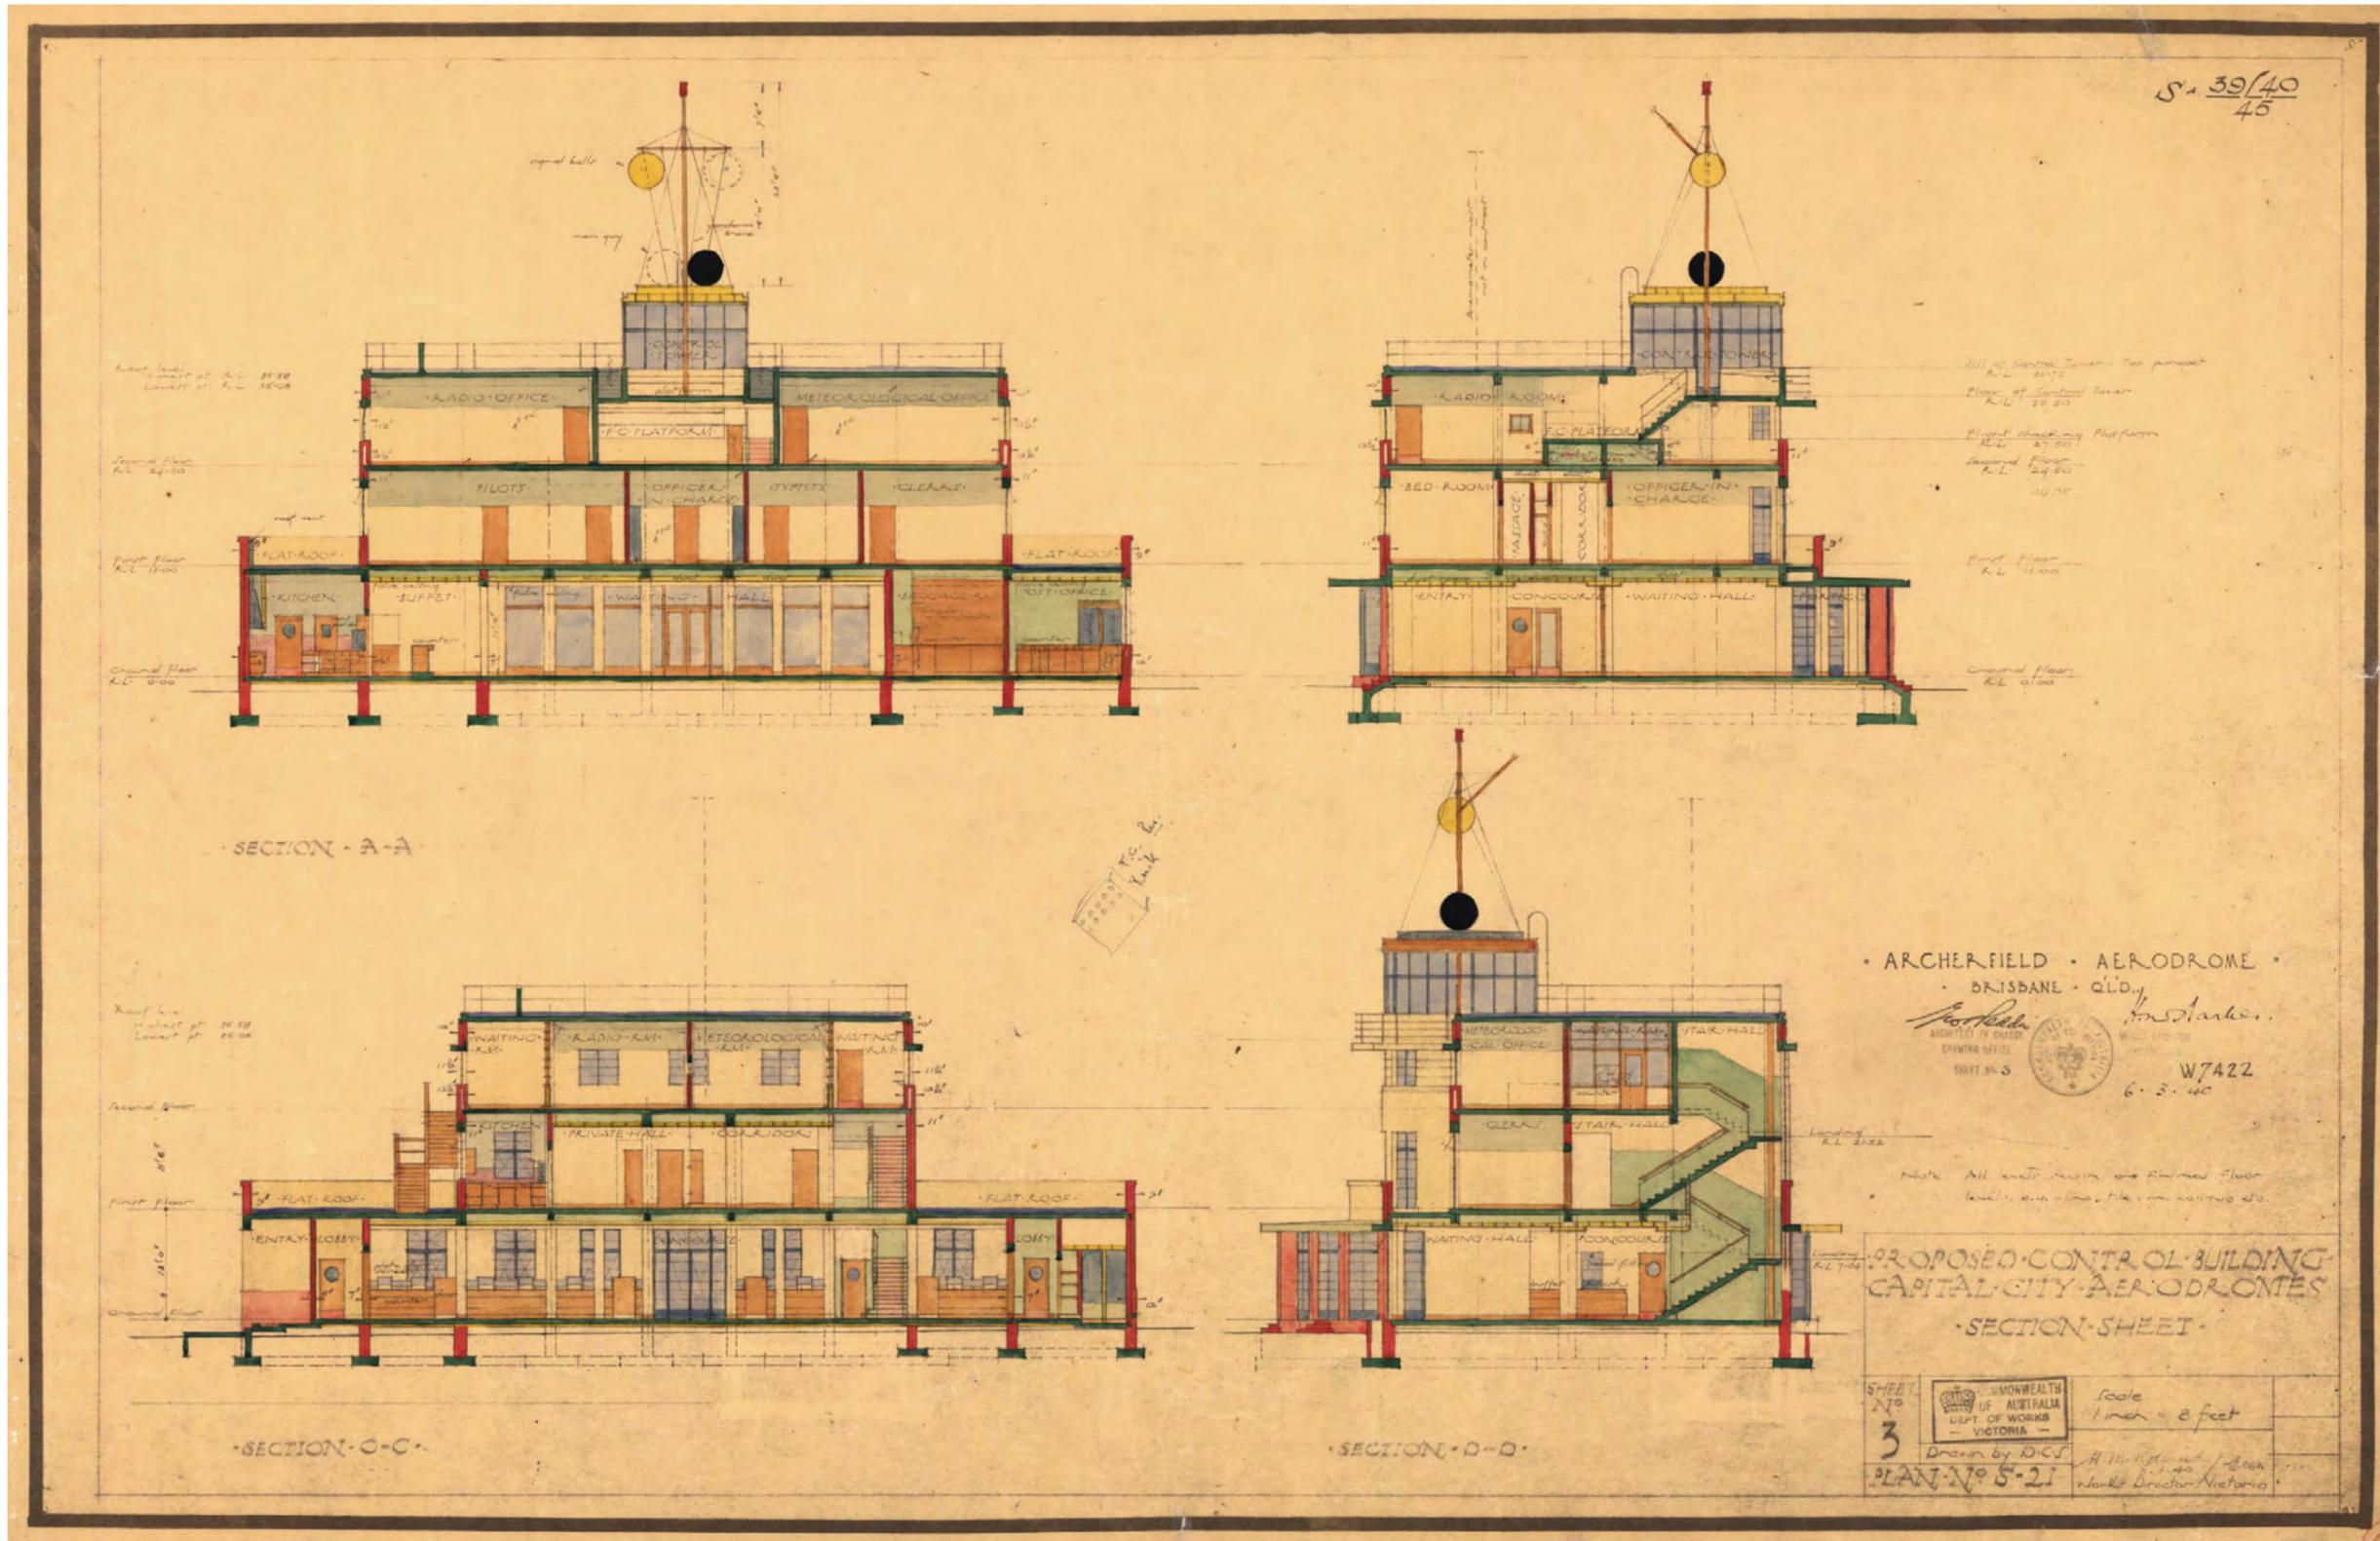
Figure 2 Operation and Administration building sections, sheet 3  
Source: National Archives of Australia

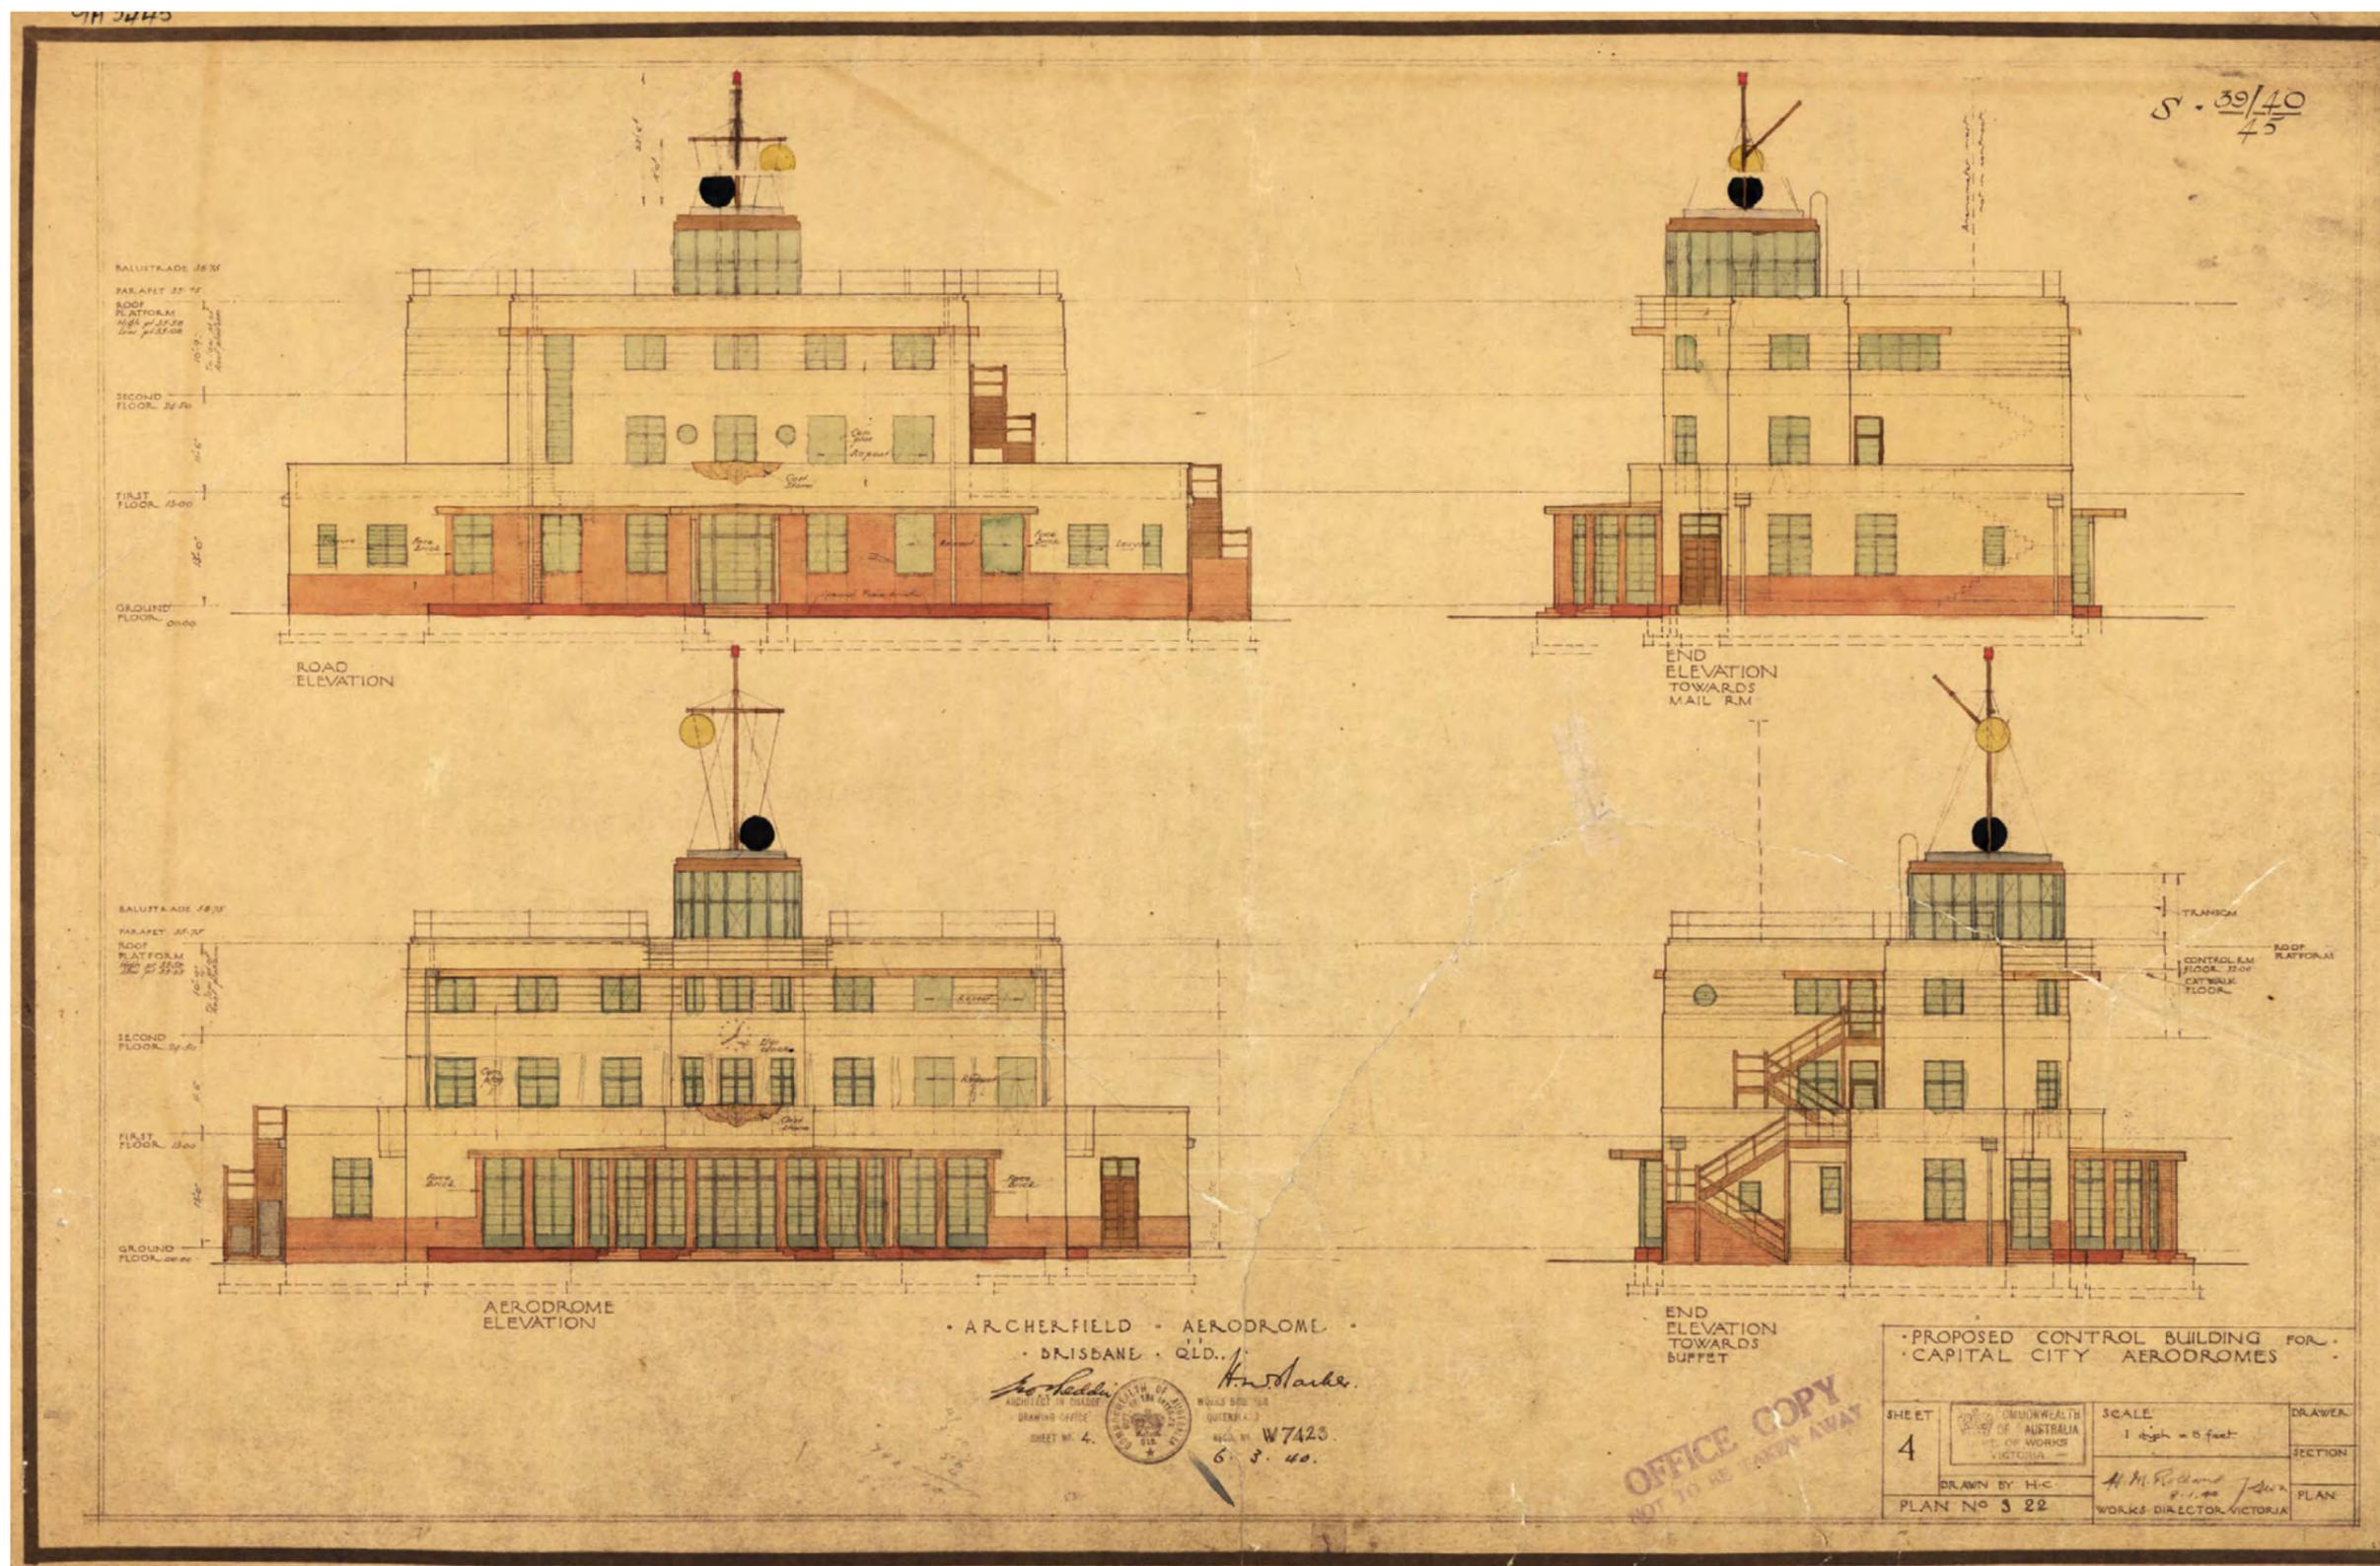
Figure 3 Operation and Administration building elevations, sheet 4  
Source: National Archives of Australia
